# Cultural Resource Inventory for the Proposed Mullan BUILD Project, Missoula County, Montana.

**Rabbitbrush Archaeological Services, LLC**

June 2020

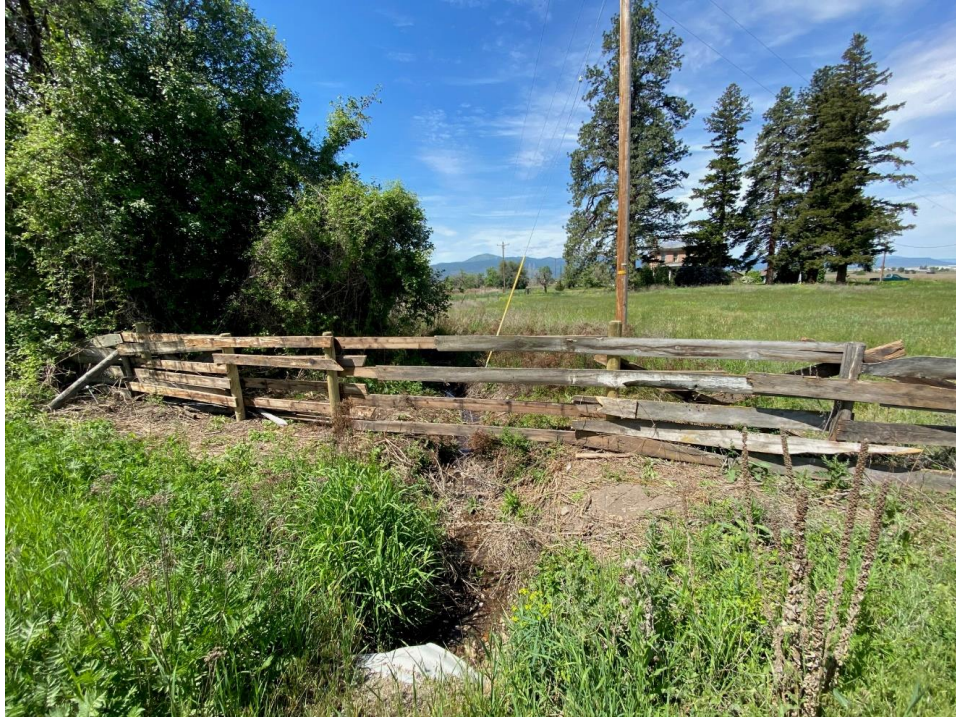
crosses under Flynn Lane (Figure 11) at the location of the Dougherty Ranch and continues west where it has been filled in just west of the Ranch eliminating its former terminus with a primary lateral of the Flynn-Lowney Ditch (24MO0550). A dilapidated and abandoned, rough-aggregate concrete headgate (Figure 12) is present just southwest of the Dougherty Ranch (24MO1781) where the extant ditch alignment turns briefly to the south.

Figure 11. The Flynn-Dougherty Ditch (24MO0901) at its culvert under Flynn Lane, view to the west. The Dougherty Ranch is pictured in the background.

greater ditch system itself are no longer present. RBAS concurs with the previous recommendation for this resource as being Not Eligible for inclusion in the NRHP. While some aspects of integrity remain, a majority have been compromised over time. No further work is recommended in regard to this resource.

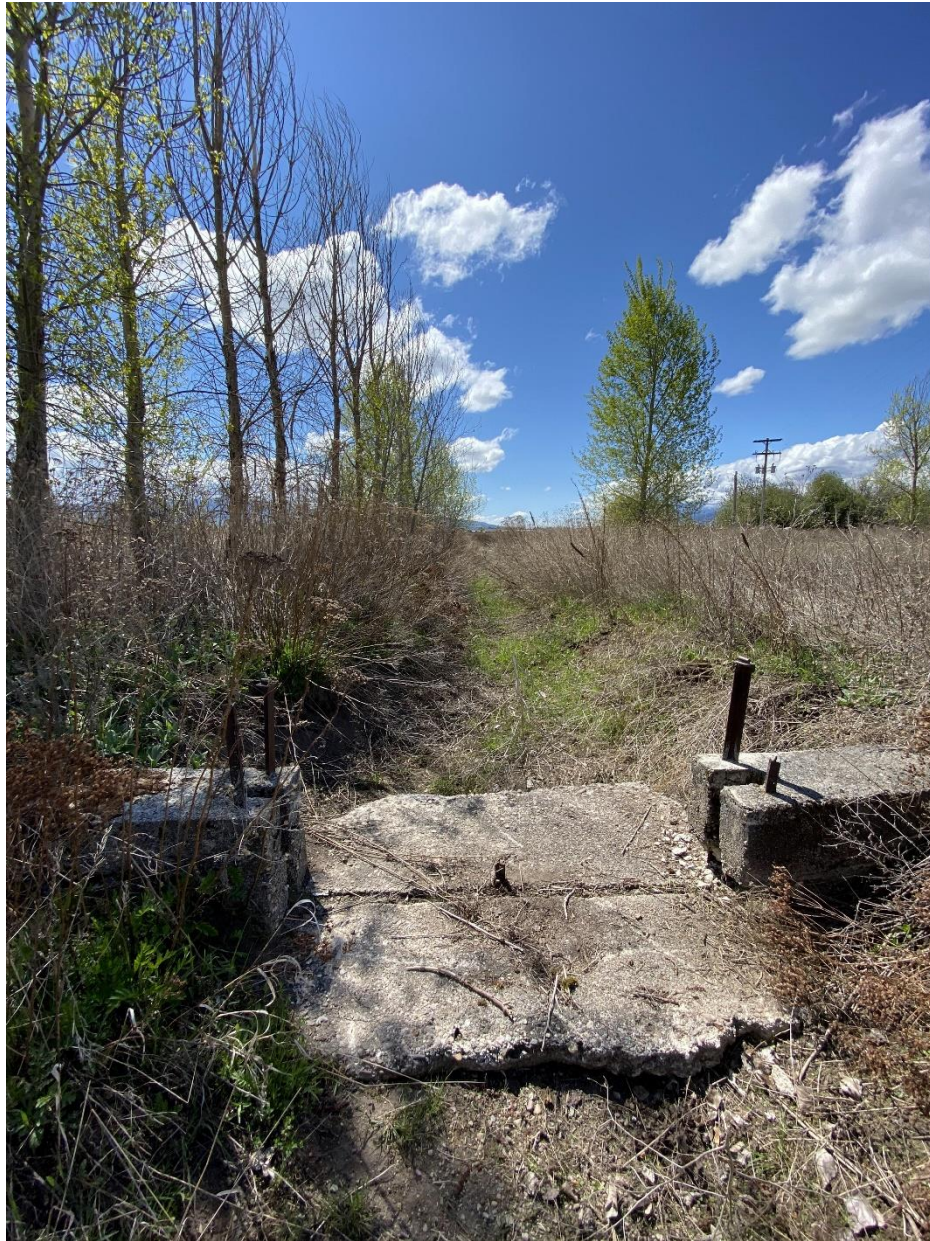
Figure 12. Abandoned headgate structure on the Flynn-Dougherty Ditch (24MO0901) at the Dougherty Ranch, view to the south.

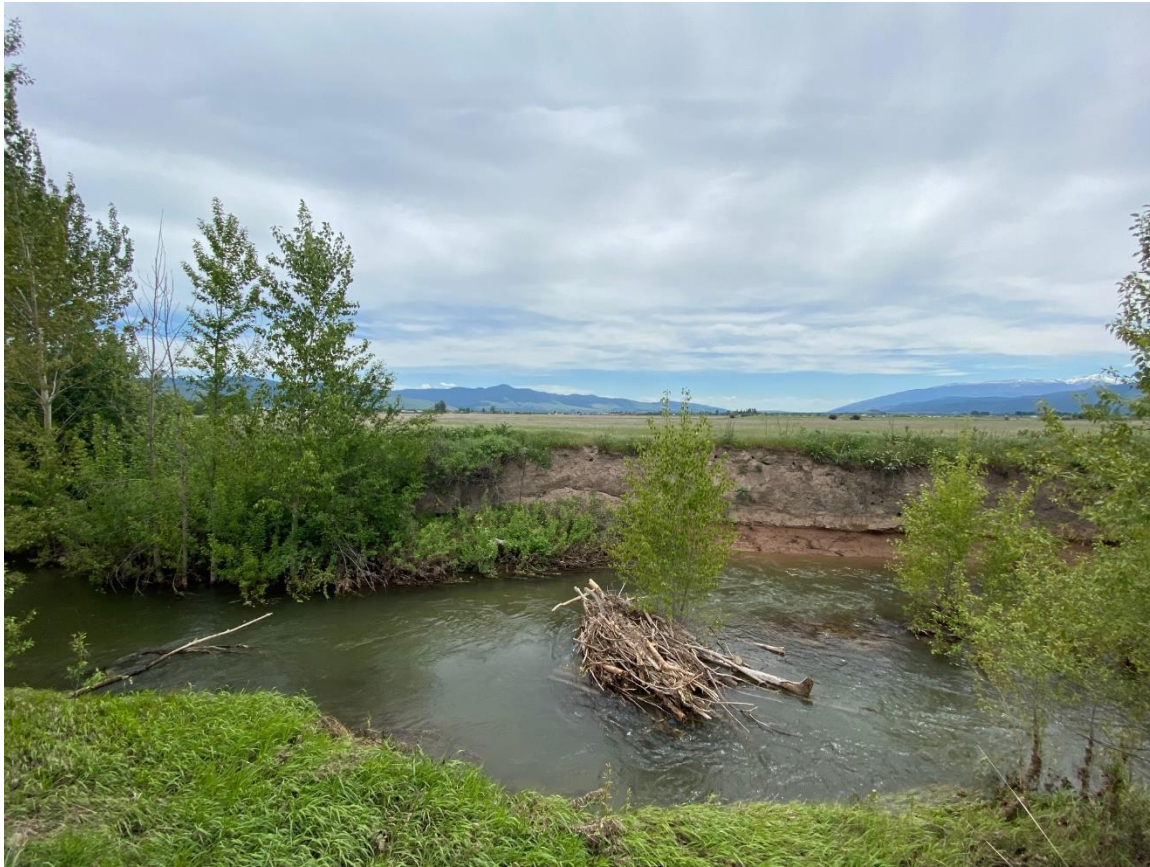
Figure 14. The Field Dougherty Ditch (24MO0902)/Grant Creek near the proposed intersection of George Elmer Dr. (north segment) and West Broadway. View to the south.

The site has been previously recommended as not eligible for inclusion the NRHP (Herbel and Beery 2006) with concurrence by the Montana SHPO. RBAS agrees with the previous determinations for this resource as being not eligible for inclusion in the NRHP. No further work is recommended in regard to this resource.

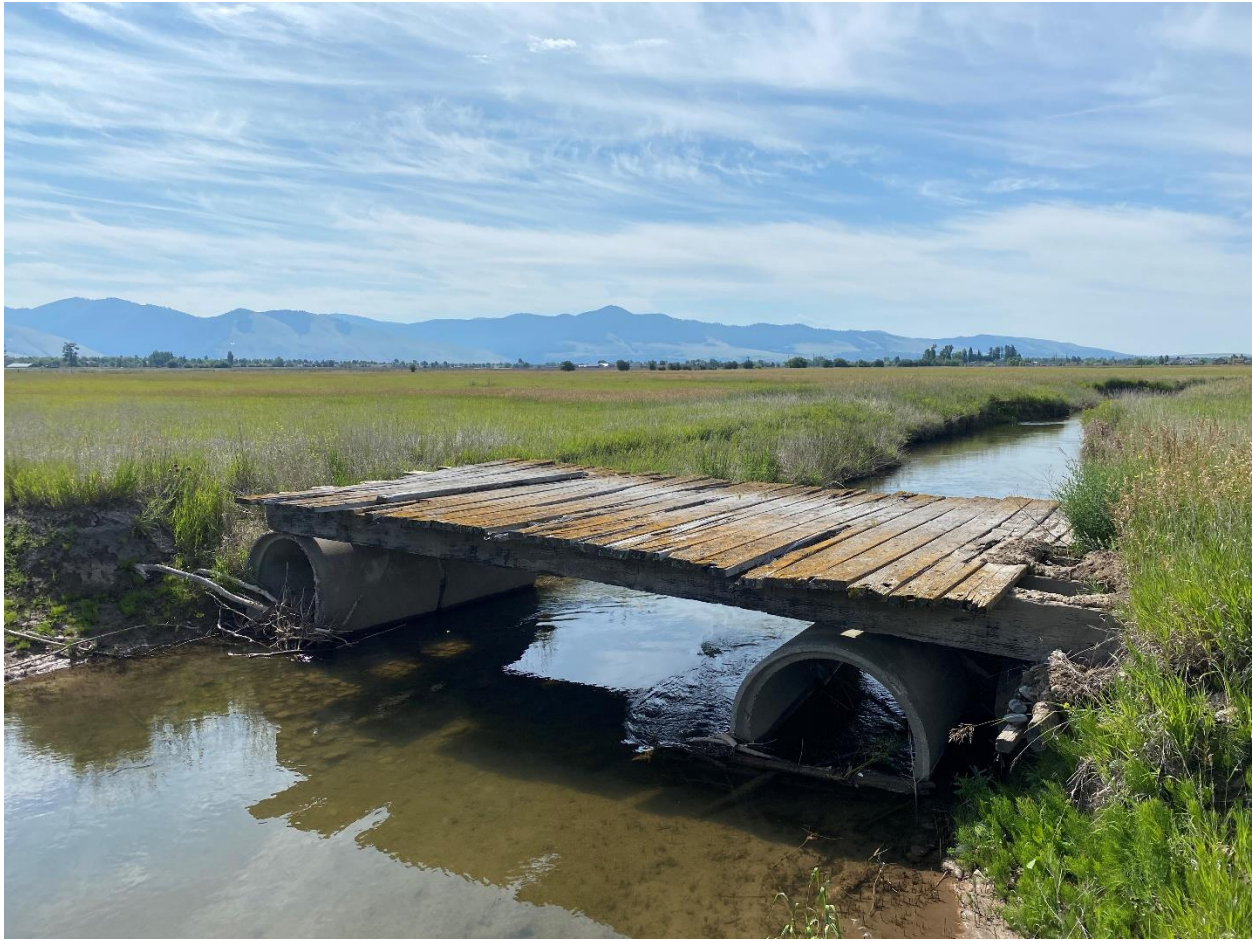
Figure 15. The Field Dougherty Ditch (24MO0902)/Grant Creek. Plank bridge originally recorded by Herbel and Beery (2006:20). View to the south.

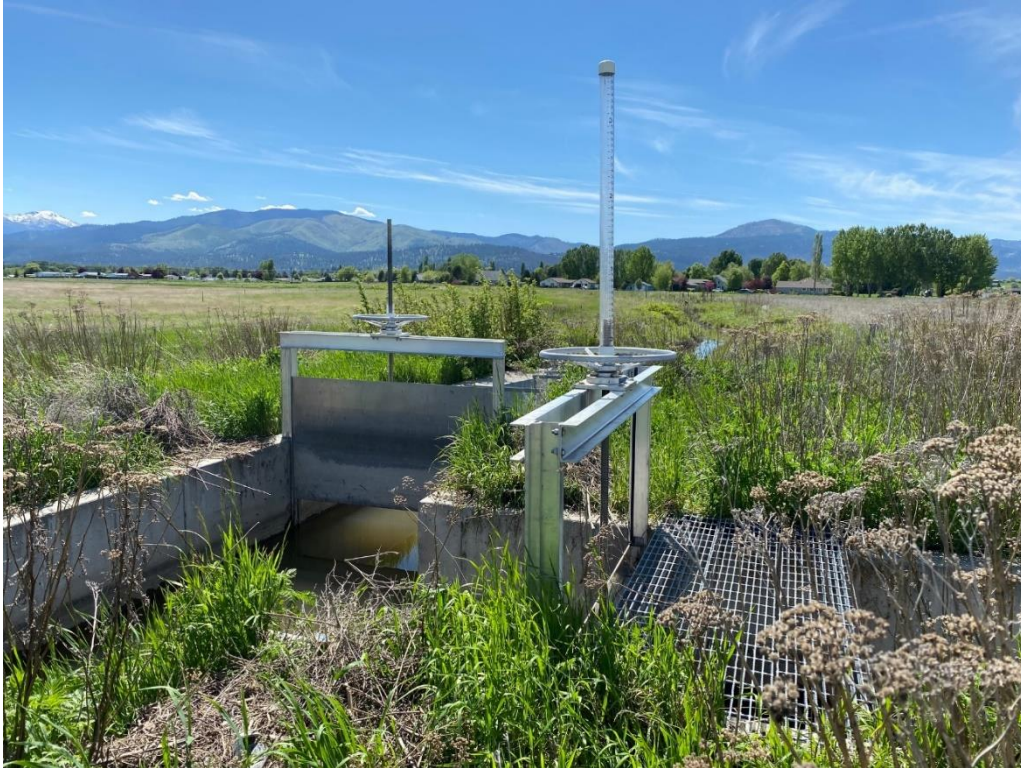
Figure 17. Newly constructed structure between George Elmer Drive and Chuckwagon Drive. View to the southwest. The headgate on the right directs flow into L2 and is a reconfiguration of the historic diversion point for L2.

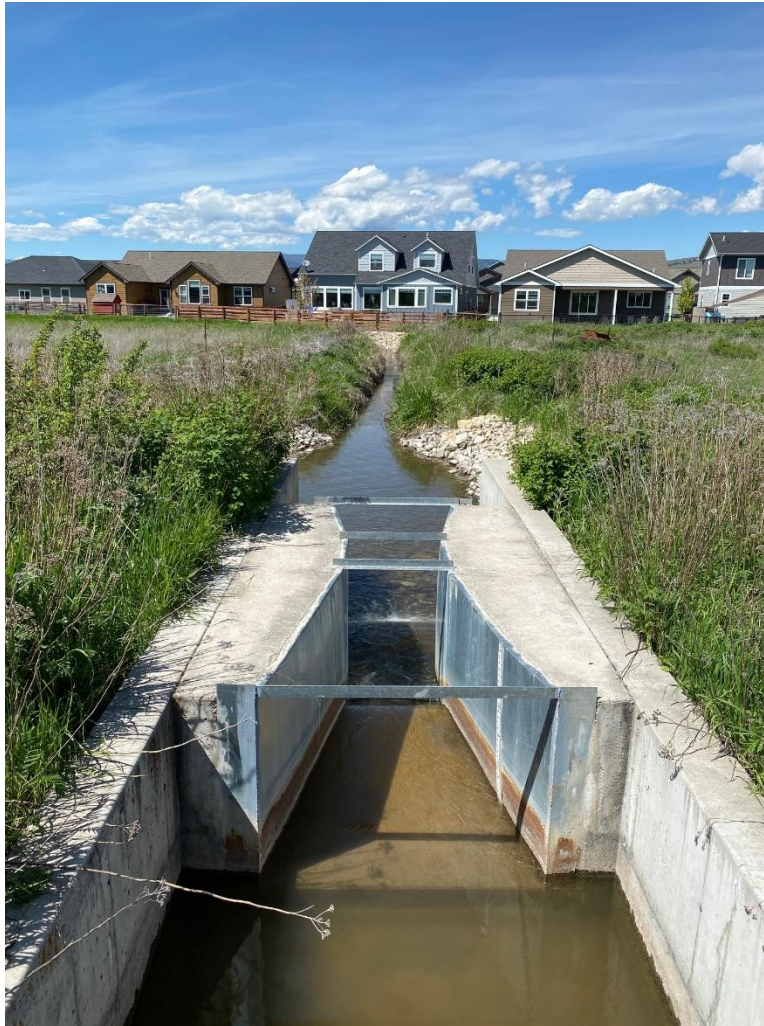
has a modern Parshall Flume<sup>8</sup> (Figure 18) located at the newly configured diversion point for primary lateral L2. The ditch (Figures 19-22) flows along the entity of its path along the southern boundary of the project area (see Figure 3).

<sup>8</sup> A Parshall Flume is a fixed, hydraulic structure that is placed in a flow stream to determine the flow of water. The flume accelerates flow by both a contraction of the parallel sidewalls and a drop in the floor elevation in the throat. Short-throated flumes like the Parshall have only one point of measurement ( $H_a$ ) at which the flow rate can be determined. A level reading taken upstream of the point of measurement will result in the flume over reading, while one taken downstream will result in the flume under reading (as the flow accelerates and the water surface draws down towards the throat). - <https://www.openchannelflow.com/flumes/parshall-flumes>

Figure 18. Newly constructed Parshall Flume at a lateral (L2) diversion point between George Elmer Drive and Chuckwagon Drive. View to the north.

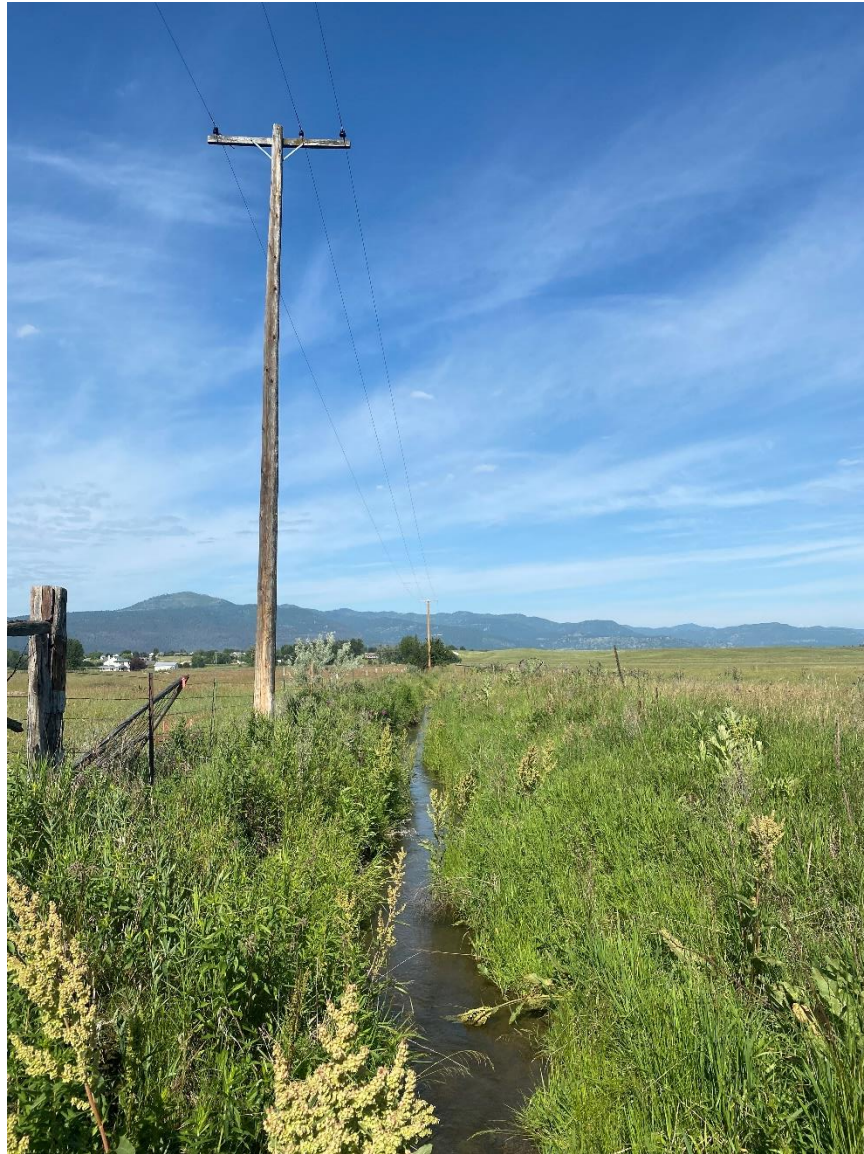
Figure 19. Photo of L2 at it is east-west run that return water to Grant Creek.

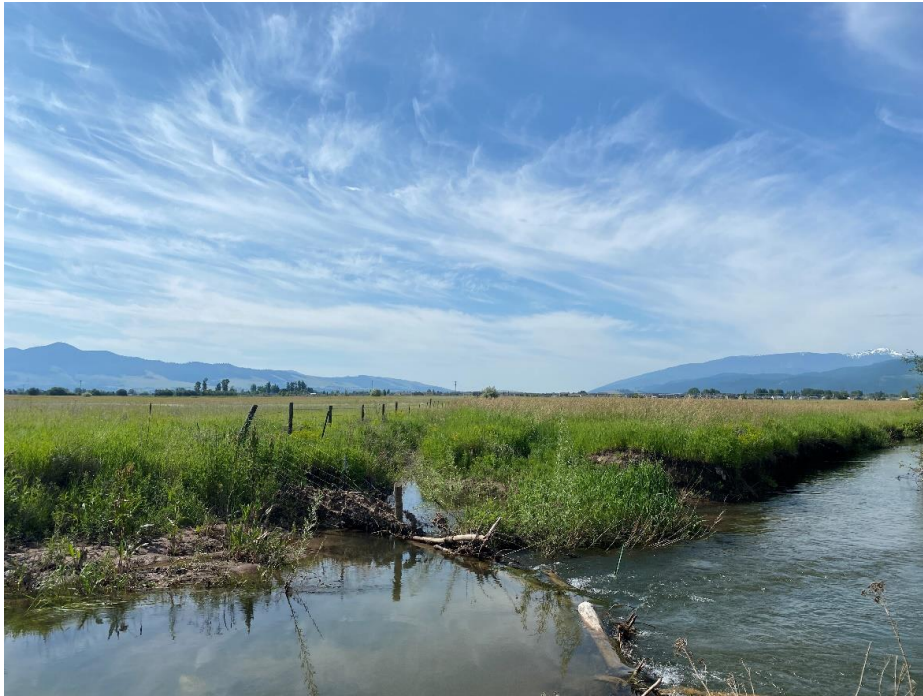
Figure 20. Overview of the confluence of L1 and the Grant Creek/Field-Dougherty Ditch 20MO0902.

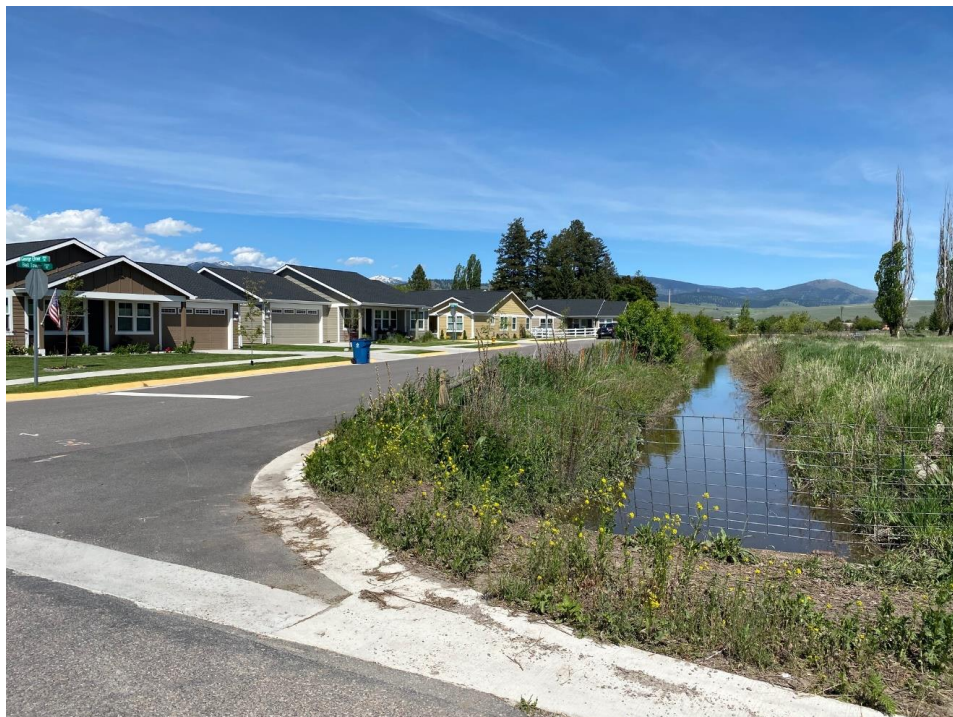
Figure 21. Overview of the Flynn-Lowney Ditch main channel at its existing culvert at George Elmer Drive. View to the east.

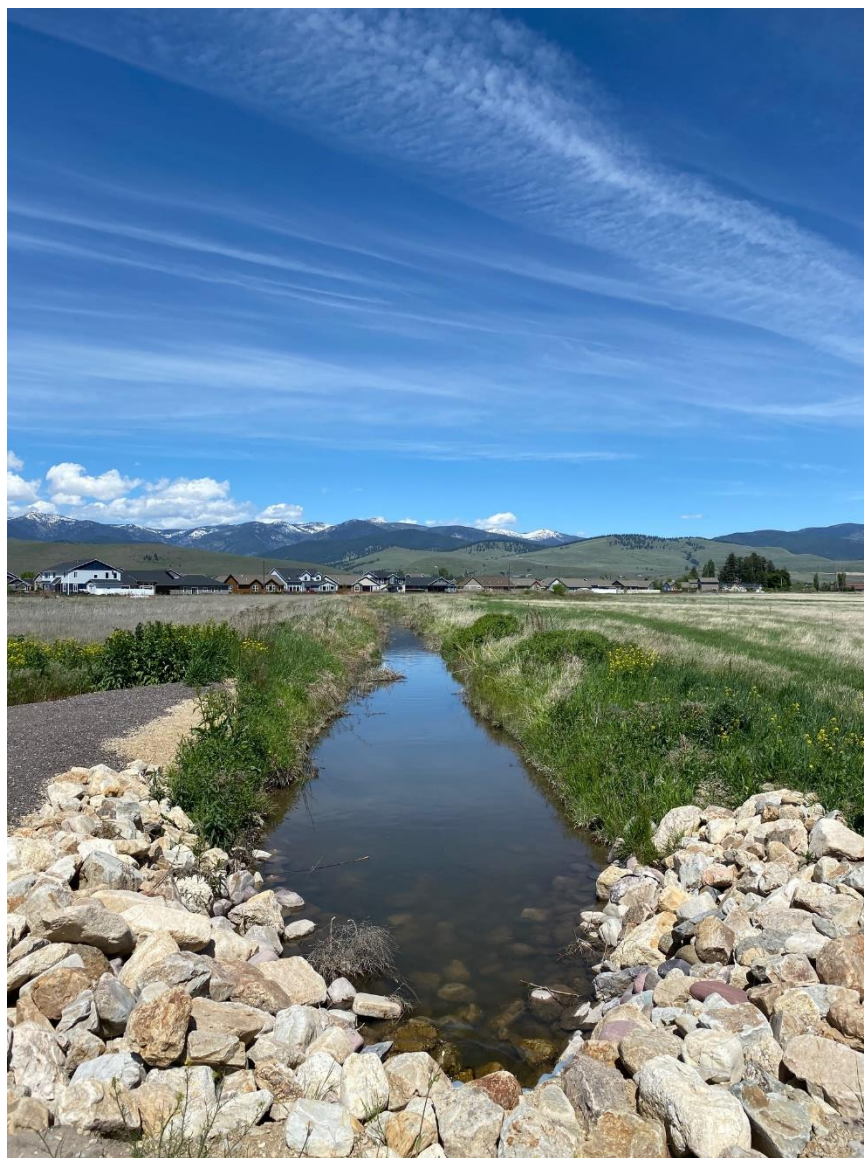
Figure 22. Overview of the Flynn-Lowney Ditch, main channel, at its existing culvert at Chuckwagon Drive. View to the northeast.

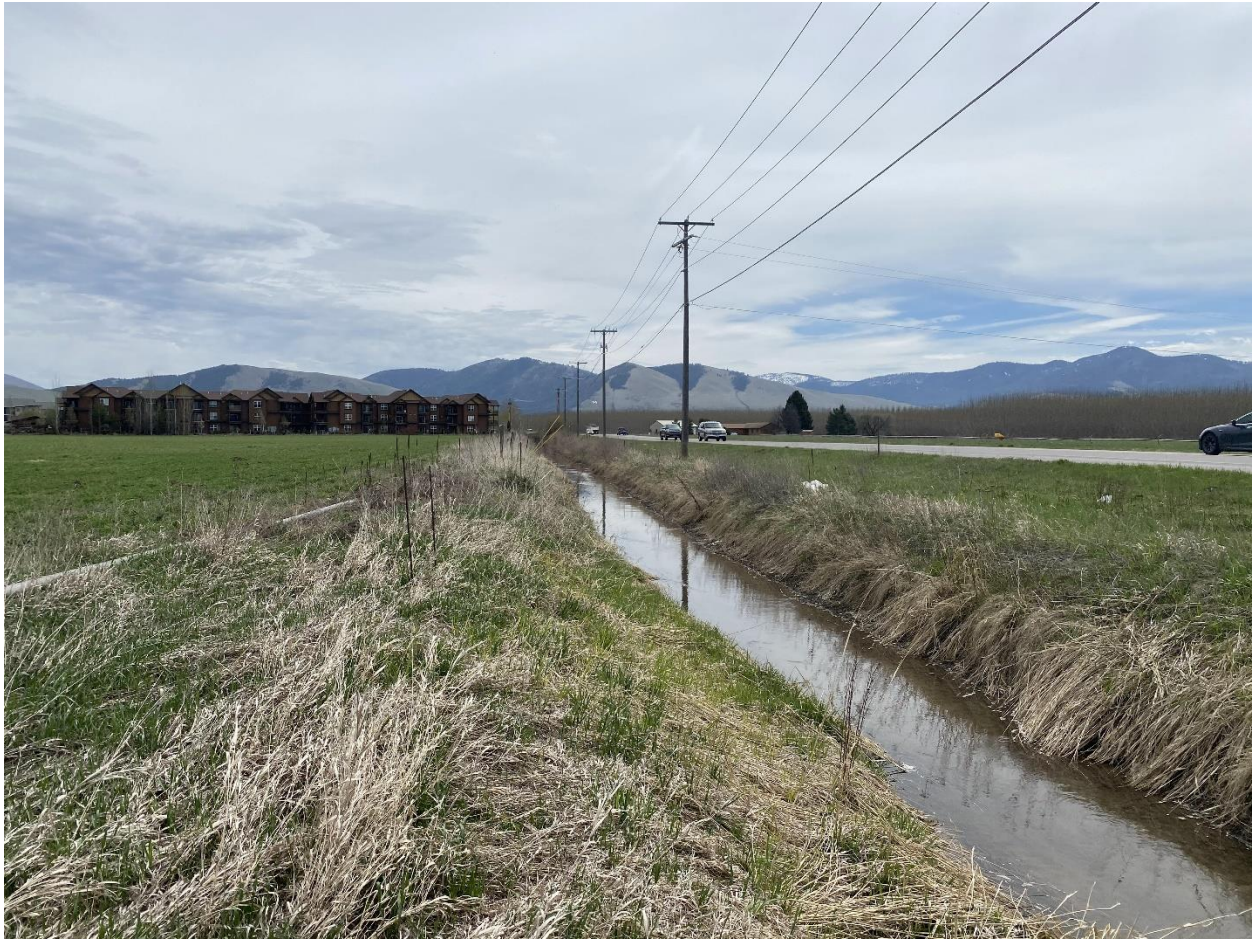
Figure 23. Overview of the Flynn-Lowney Ditch main channel at the proposed intersection of Mullan Road and the proposed extension of Mary Jane Boulevard and the location of the proposed Mullan Trail pedestrian path. View to the east.

eligibility. It is recommended that the proposed project would have No Adverse Effect to the Flynn-Lowney Ditch (24MO0550). The proposed project would involve placing approximately 125 linear feet of the ditch into a pipe to allow for the extension of Mary Jane Boulevard at its new intersection with Mullan Road. The existing ditch alignment would be perpetuated, as would its historic function, and there would be no diminution in the amount of water it carries. No mitigation is currently proposed or recommended for the effect on the Flynn-Lowney Ditch.

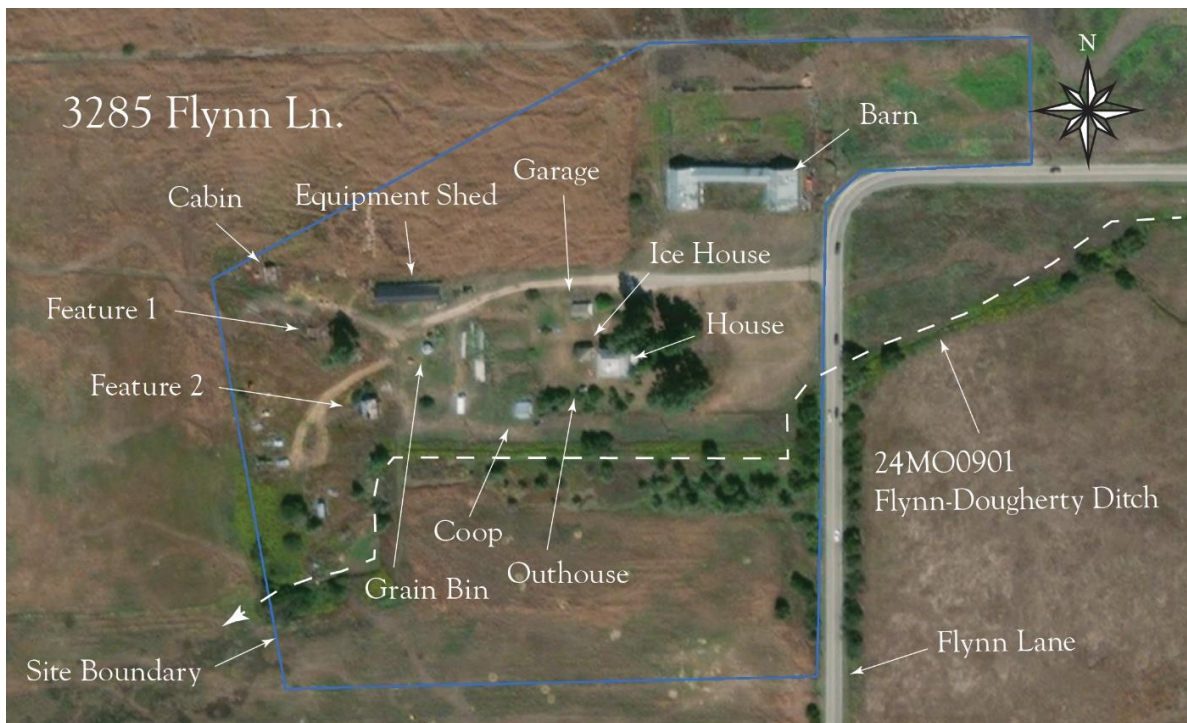
Figure 26. Site map of the location of the Dougherty Ranch.

The Dougherty Ranch (Figure 24) is located within the current study area and was evaluated in part due to its relationship with the proposed Flynn Lane Trail (see Figure 3) that would bisect the property (Figure 25). The site (Figure 26) consists of a series of functional farm buildings, the primary residence, icehouse, as well as a boneyard of agricultural equipment (trailers, cultivators, combines, grain auger, hay baler, hay rakes, etc.).

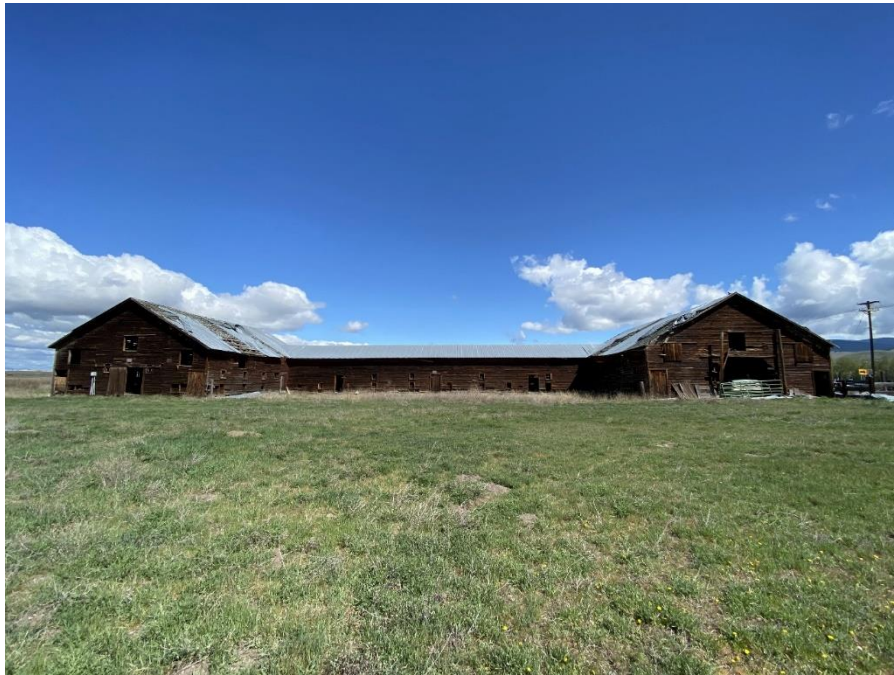
**Barn:** The barn is a circa 1920<sup>14</sup> front facing compound U-plan style stock barn (Figure 27). It is one and a half stories, with a low-pitch single-end-view gable per roof line in the plan. The barn is oriented with its front to the south with each wing having front gables and the median span having a cross gable. Roofing materials consist of corrugated tin sheets covering decomposing asphalt shingles. The barn sits on an uncut stone and mortar foundation (Figure 28), likely from stones that would have been available on site or locally. Each wing measures approximately 60 by 40 ft with the central span running approximately 125 by 20 ft. The Montana Cadastral Property Record Card lists each wing at 2436 square feet (sq ft) and the center span a 3080 sq ft for a total of 7952 sq ft of a standard barn(s) that constitutes building improvements 4-6.

Figure 27. Photograph of the barn, view to the north.

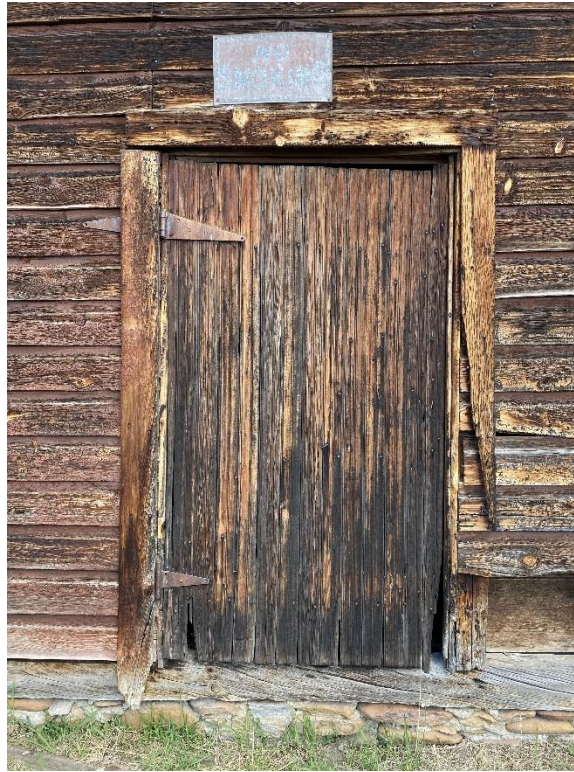
Figure 28. Photograph of representative door on the north elevation, showing door type, casement, and the uncut stone foundation.

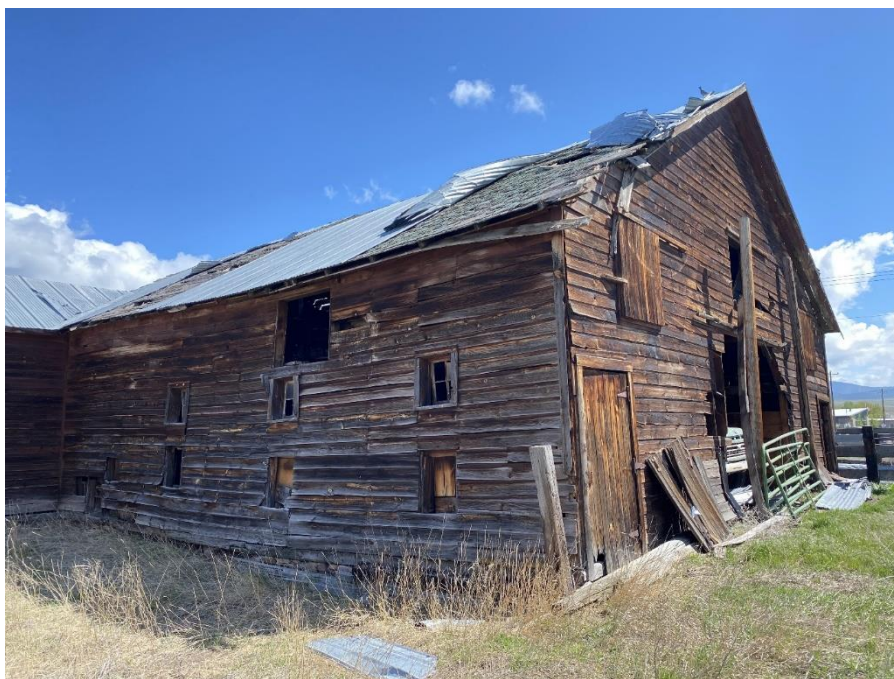
Windows are almost entirely two-over-two, four-light windows with wood casements, wood reveals, and wood sills. The west elevation of the east wing has six such windows evenly spaced with a 6 ft square opening to the upper hay loft (Figure 29). The center span, south elevation has twelve such windows, four in an upper row, with the remaining an even spacing below. This elevation also has 3 points of entry, vertical plank wooden doors with wood casements. The east elevation of the west wing (Figure 30) is identical the east wing with the exception of one additional window, a horizontal three-over-three six-light window with the same casement, reveal, and sill.

Figure 29. Photograph of the southwest corner of the east wing, view to the northeast.

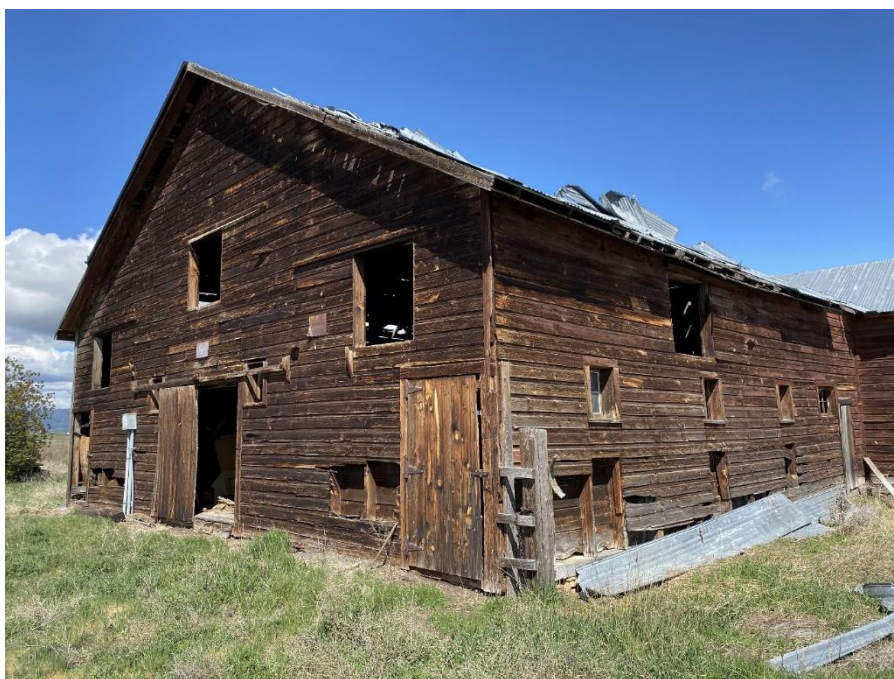
Figure 30. Photograph of the southeast corner of the west wing, view to the northwest.

The south elevation of the wings both possess a series of three, six ft square sliding doors as entry to the upper loft and two primary entry doors that are identical to those found on the south elevation of the center span. The east wing has a larger central opening for vehicle access while the west wing has a smaller 8 ft square slider door.

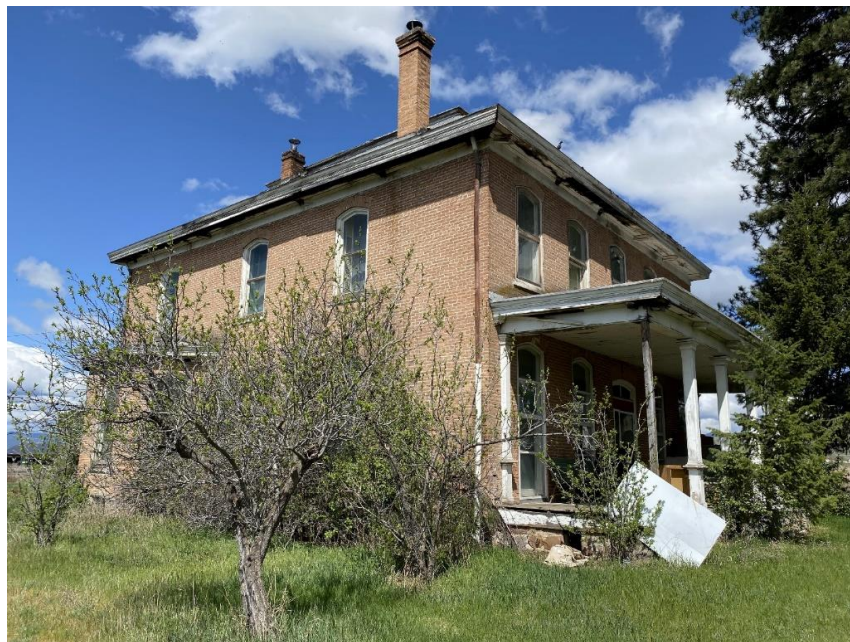
The east elevation has a full width one-story 403 square ft covered porch with a large cornice, simple squared decorative columns, two of which, at each corner appear to have been replaced. A smaller 54 square ft covered porch is present at the west elevation. In addition to the east elevation primary entry, there is a smaller “mud room” entry on the west elevation that connects to the garage with a concrete pathway. A covered entry is also present on the north elevation with a two-light transom and pediment, identical to the east elevation entry with the exception of the east elevation having single pane side-lights.

Windows are almost entirely single-hung one-over one windows with an arched (extended segmental) top and a decorative brick pediment with a wood sill and reveal. The upper story has four equally spaced windows on both the east and west elevations with the north and south elevations have just three. There are basement windows (two each on the north and south elevation, one on the west elevation) that are a simpler three-over-three six-light window with a wood lintel. The irregular plan north elevation has one fixed three-pane window with a brick sill. This window stands out as temporally different indicating that this was a remodel or addition as a portion of the brick pattern is also interrupted here.

Figure 32. Southeast corner of the house showing the south and west elevations.

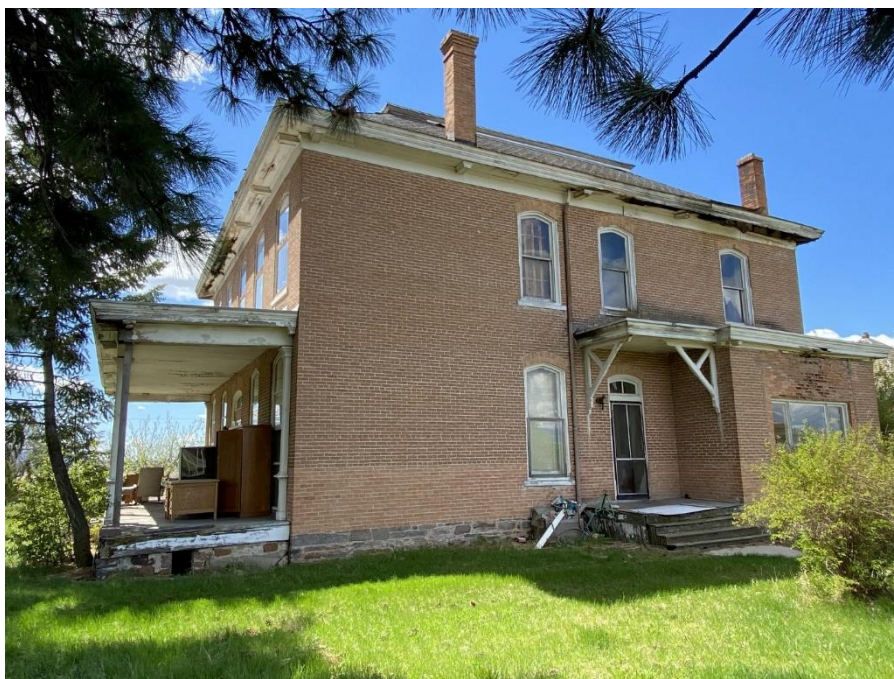
Figure 33. Northeast corner of the house showing the north and west elevations.

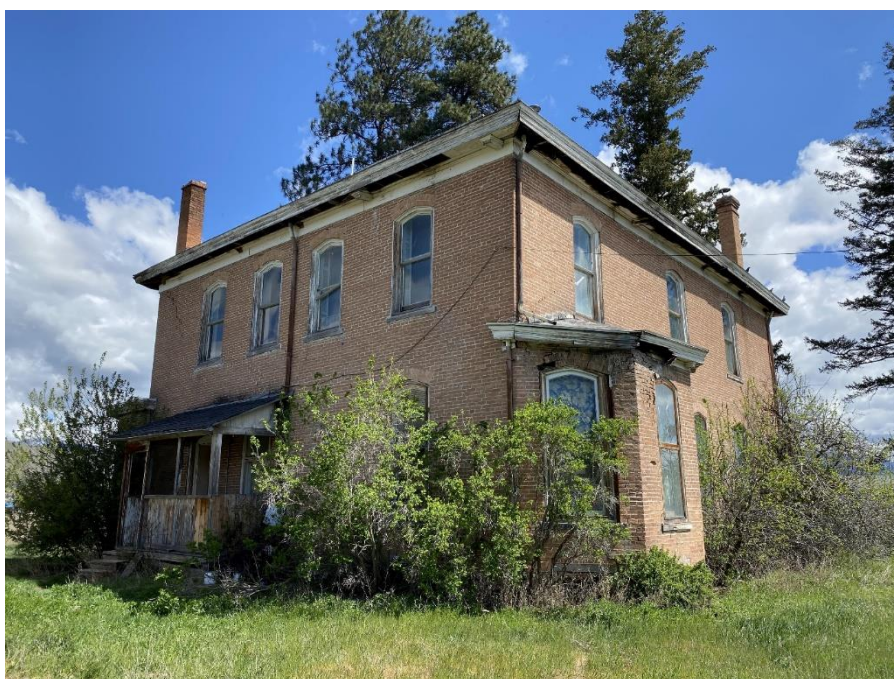
Figure 34. Southwest corner of the house showing the south and east elevations.

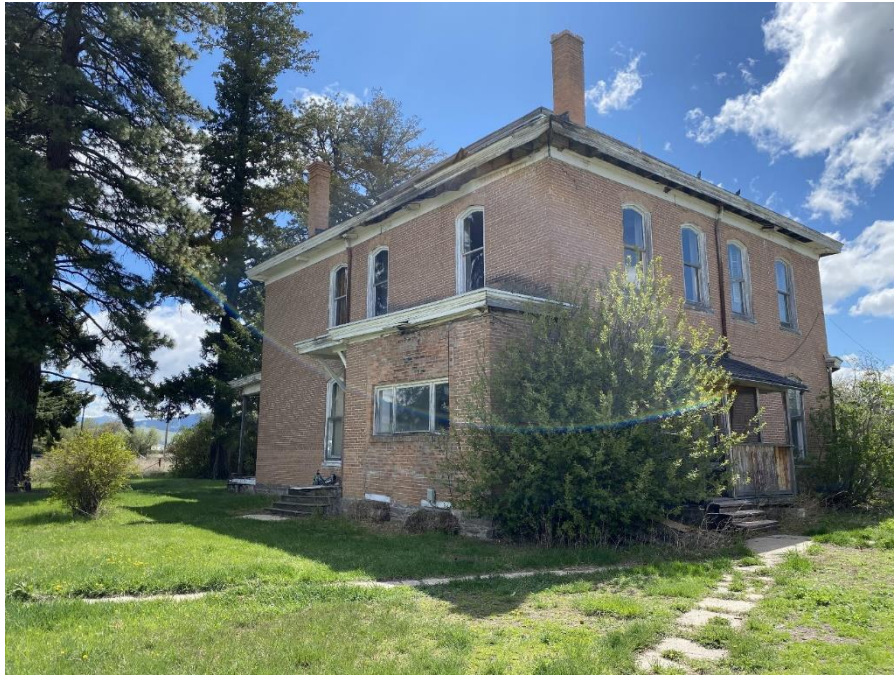
Figure 35. Northwest corner of the house showing the north and east elevations.

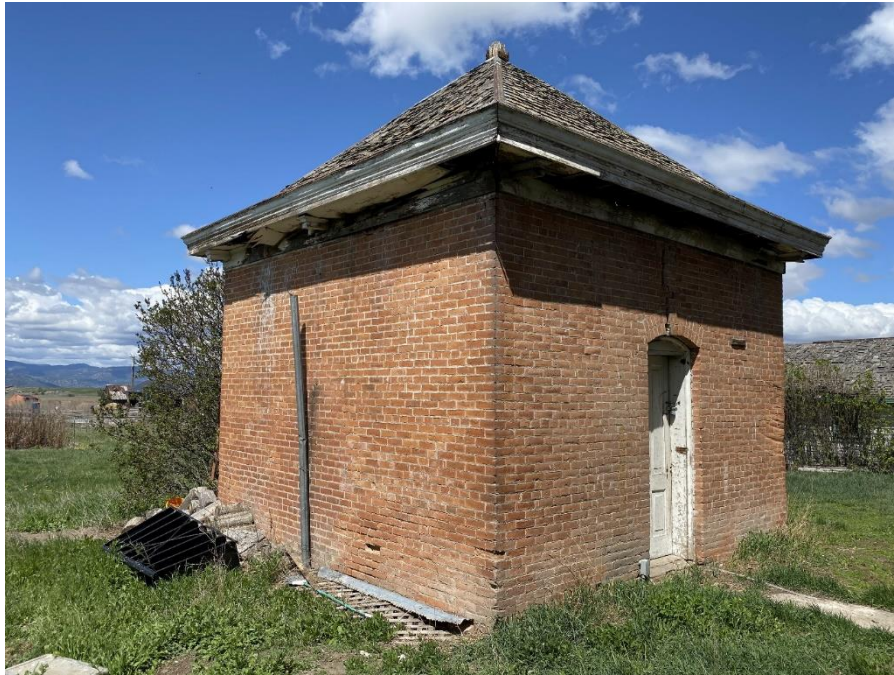
**Icehouse:** The icehouse a 324 square ft (18 by 18 ft), one-unit simple plan building with a normal pitch pyramidal roof line and plain wood shingles (Figure 36, Figure 37). There is a single two-panel entry door on the east elevation closest to the house. The door has a deep casement and a brick pediment identical to the house. It also has an identical wide-eve with brackets as the house. The foundation is irregular-course cut stone and the brick pattern is English with seven rows of stretchers per header row. The west elevation is obscured by a lilac though has a single wood frame, fixed window with brick pediment. This buildings construction was likely contemporaneous with the house given array of matching features.

Figure 36. Southeast corner of the icehouse showing the south and east elevations

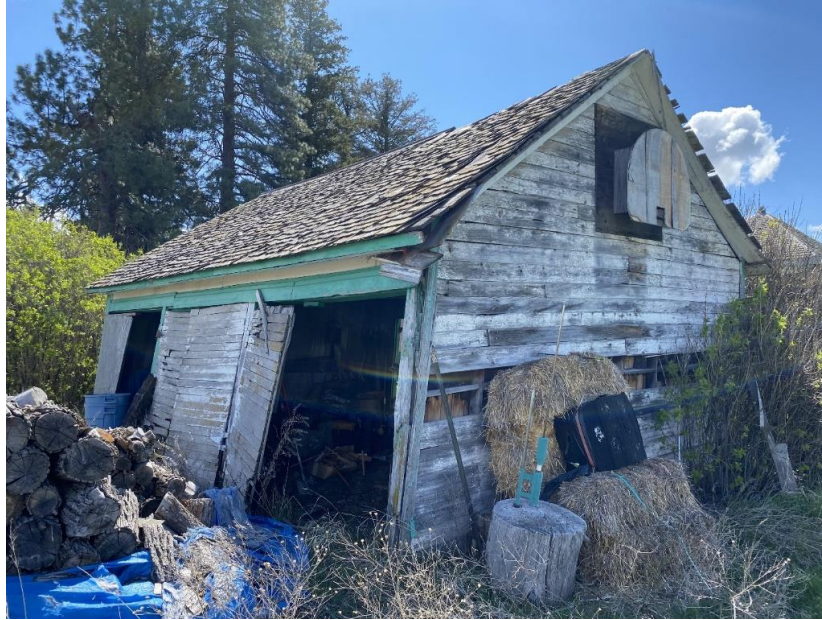
Figure 38. Northwest corner of the garage showing the north and west elevations.

**Garage:** The garage is ca. 1920, 450 square ft, detached three-bay garage that opens to the north with standard hinged plank doors (Figure 38). It is side-gabled, medium pitch, with a basketball hoop on the west elevation. Shingles are plain wood shake shingles and there is a standard door opening on

the south elevation with a poured cement path that leads to the house. There is a single three-over-three six-light window on the south elevation just west of the door.

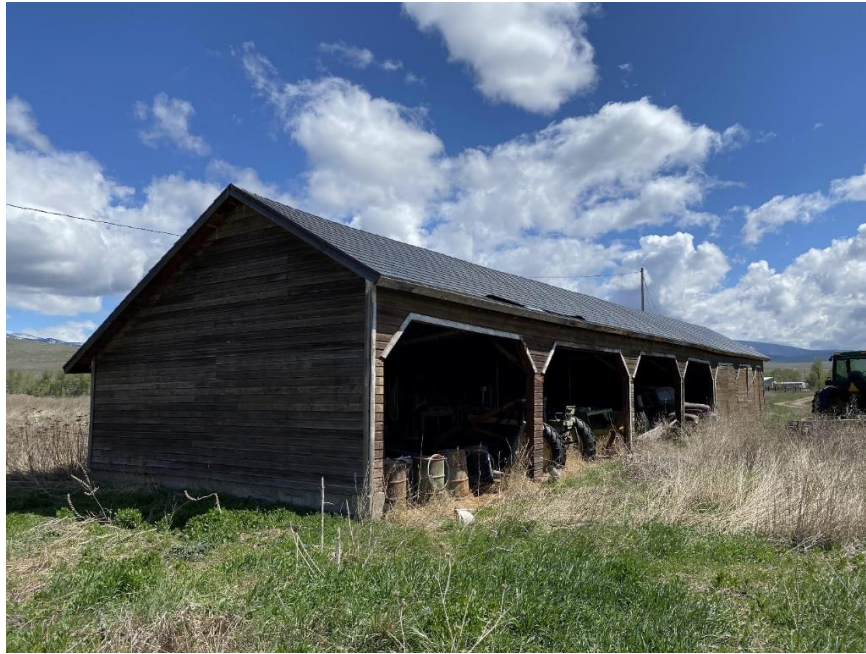
Figure 39. Southwest corner of the equipment shed showing the south and west elevations.

**Equipment Shed:** This six-bay equipment shed (Figure 39) is ca. 1930 and approximately 2500 square ft (100 by 25 ft). The westernmost four bays are open while the easternmost three have hinged plank doors. The east elevation has single three-panel man door and a three-over-three six-light window. The saltbox style building is side-gabled, normal pitch with eaves, with composite shingles. The west elevation has no features, while the north elevation has one small wood casement fixed three-light window with a wood sill. The interior is home to tractor parts, tires, oil drums, implements for hay production, and a 1949 International Harvester flatbed truck that does not appear to be in working order.

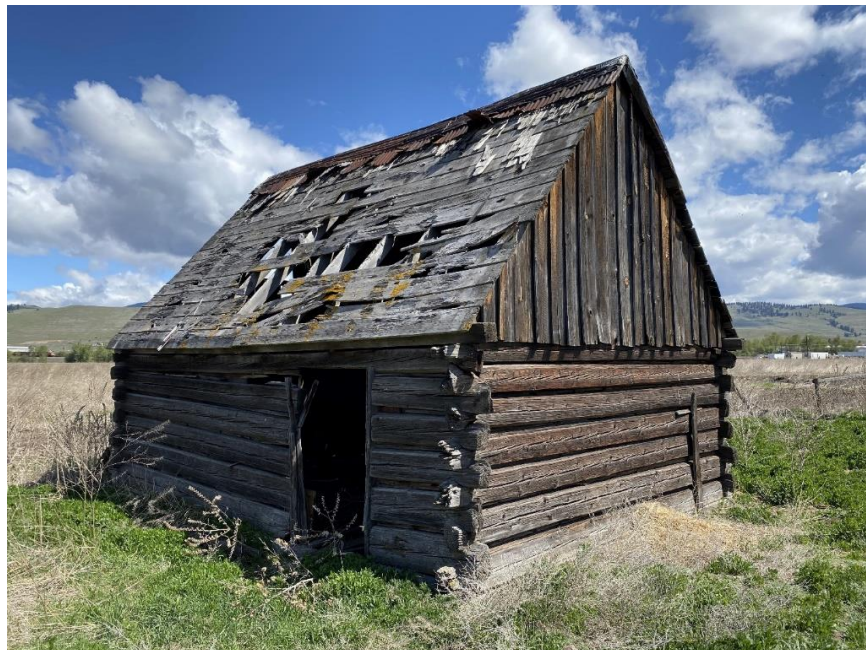
Figure 40. Southwest corner of the cabin showing the south and west elevations.

**Cabin:** The cabin is a steep-pitched side-gable cabin with seven courses of diamond-notched logs (Figure 40). It has 391 square ft (17 by 21 ft) and a door in the west elevation. No windows are present. Corrugated tin roofing covers and older layer of simple rectangular shingles. It is not clear what the function of this cabin is. It is possible that this was a dwelling occupied by the England family prior to the construction of the main house.

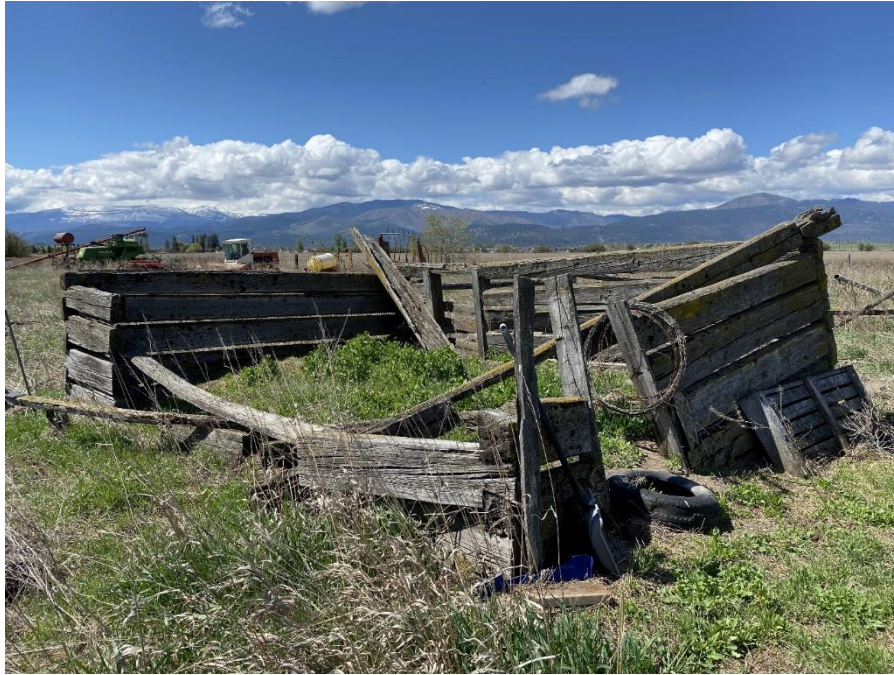
**Feature 1:** Feature 1 is the remains of 19 by 13 ft, six-course high log building (Figure 41). The logs are milled and dovetail notched. It is likely that this structure would have been contemporaneous to the cabin located nearby and was likely a small barn.

Figure 41. Overview of Feature 1, view to the south.

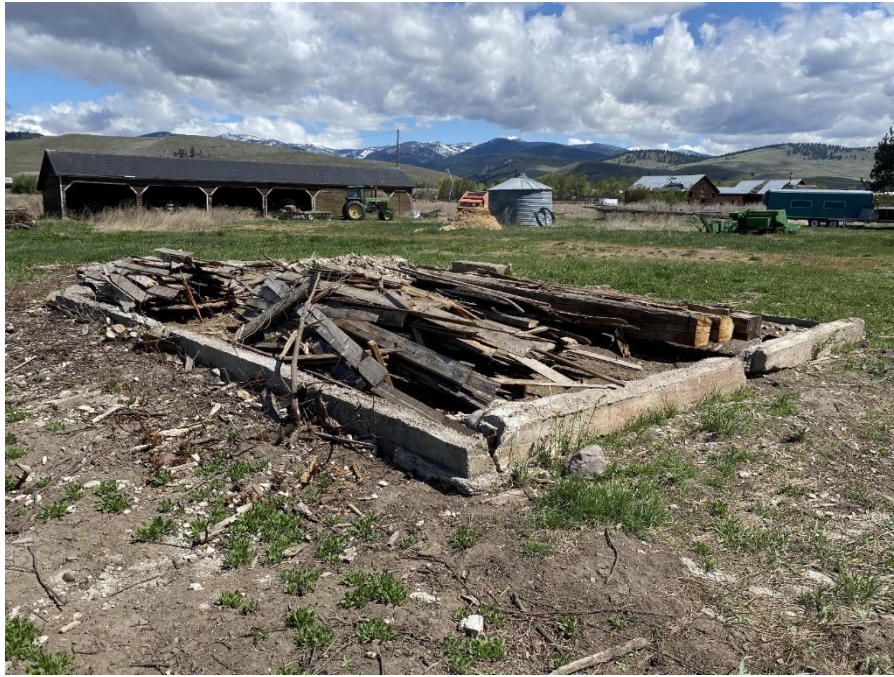
**Feature 2:** Feature 2 is a 20 by 30 ft cement foundation with miscellaneous building debris within (Figure 42). Earlier air photos (ca. 2016) of the site show a building present here that has since been torn down.

Figure 42. Overview of Feature 2, view to the south.

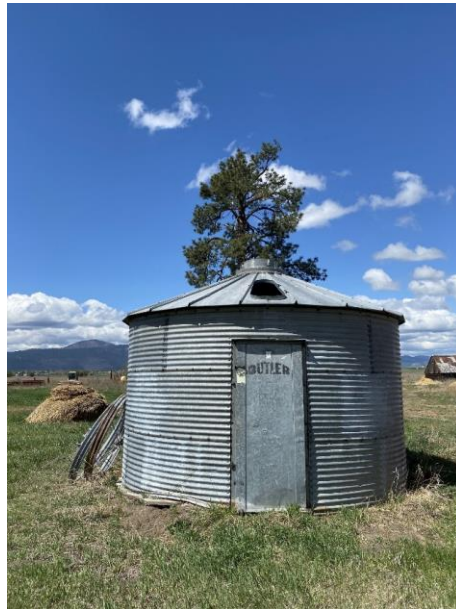
Figure 43. Butler Grain Bin, view to the west.

**Grain Bin:** The grain bin is galvanized steel, 14 ft in diameter and 8ft in height (Figure 43). The door is stamped with “BUTLER MFG COMPANY”. The capacity of this bin would have been approximately 985 bushels of grain<sup>15</sup>.
