# Cultural Resource Inventory for the Proposed Mullan BUILD Project, Missoula County, Montana.

**Rabbitbrush Archaeological Services, LLC**

June 2020

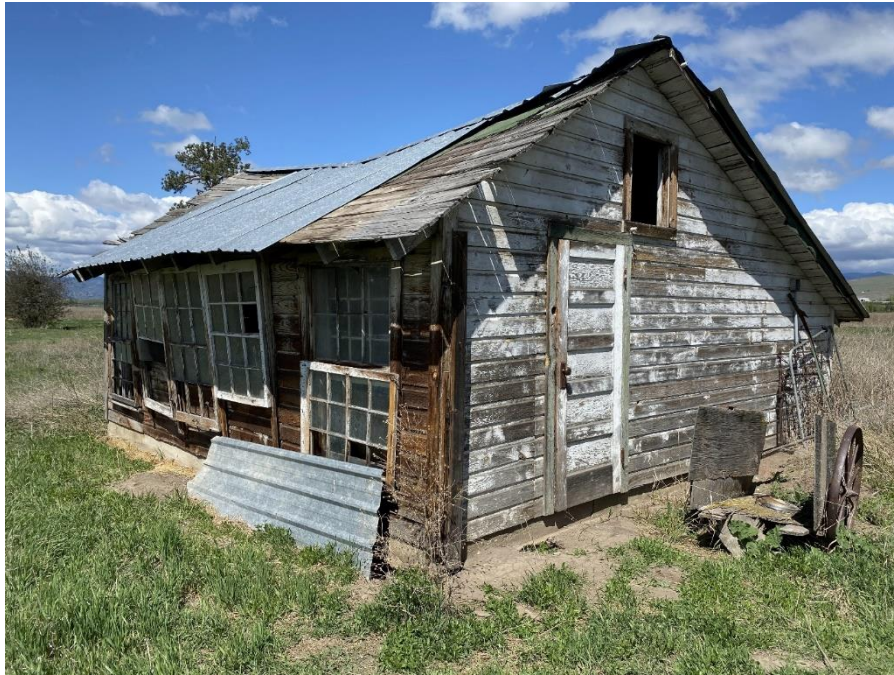
Figure 44. Southeast corner of the coop showing the south and east elevations.

**Coop/Greenhouse:** This building is a 462 square ft saltbox style building with a side gable and corrugated tin roofing covering aged composited shingles. The entire south elevation is comprised of three-over-three six-light, four-over-four twelve-light, and three-over-three twelve-light windows (Figure 44). There is a small 2.5 ft by 2 ft opening in each gable face and a narrow 6 panel door on the east elevation. The interior has an array of gardening equipment and nesting boxes. Land to the north of this building is where a large garden had been present in the past.

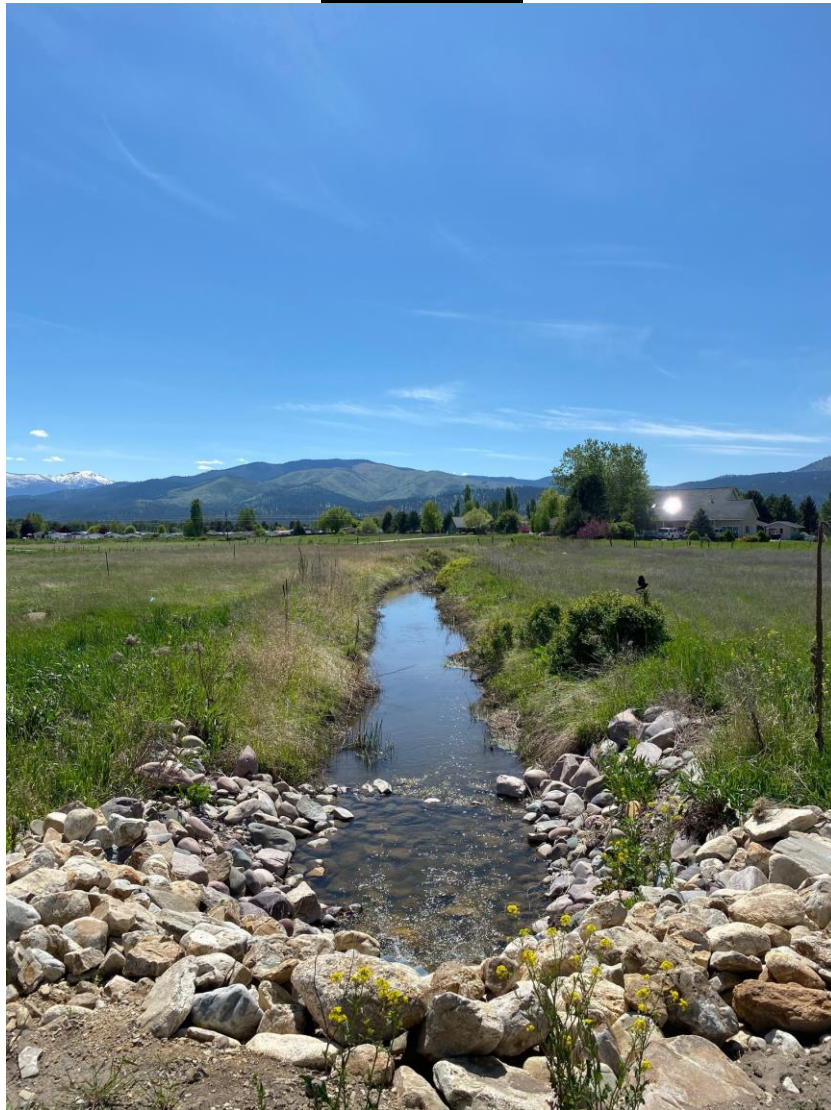
Overview of the Flynn Lowney ditch at its crossing at Chuckwagon Drive. View to the southwest.

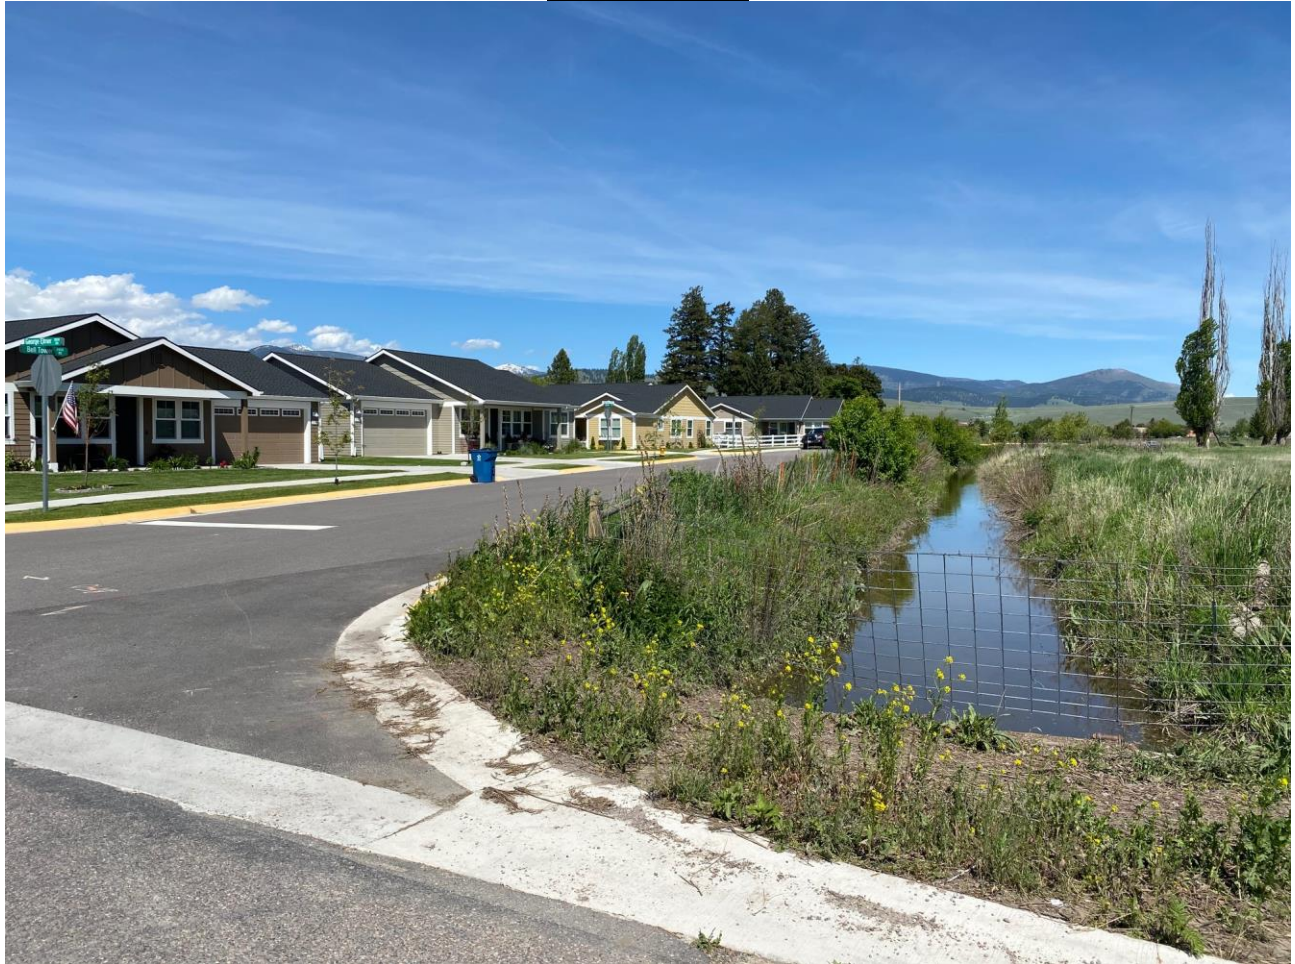
Overview of the Flynn Lowney ditch at its modern crossing at George Elmer Drive. View to the east.

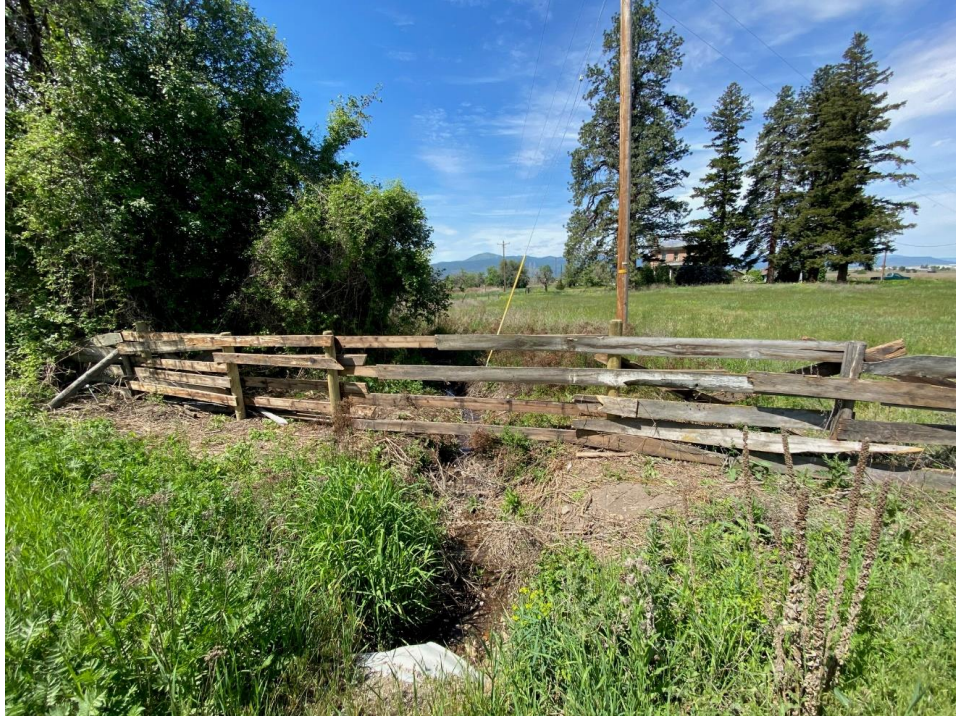
The Flynn-Dougherty Ditch (24MO0901) at its culvert under Flynn Lane, view to the west. The Dougherty Ranch is pictured in the background.

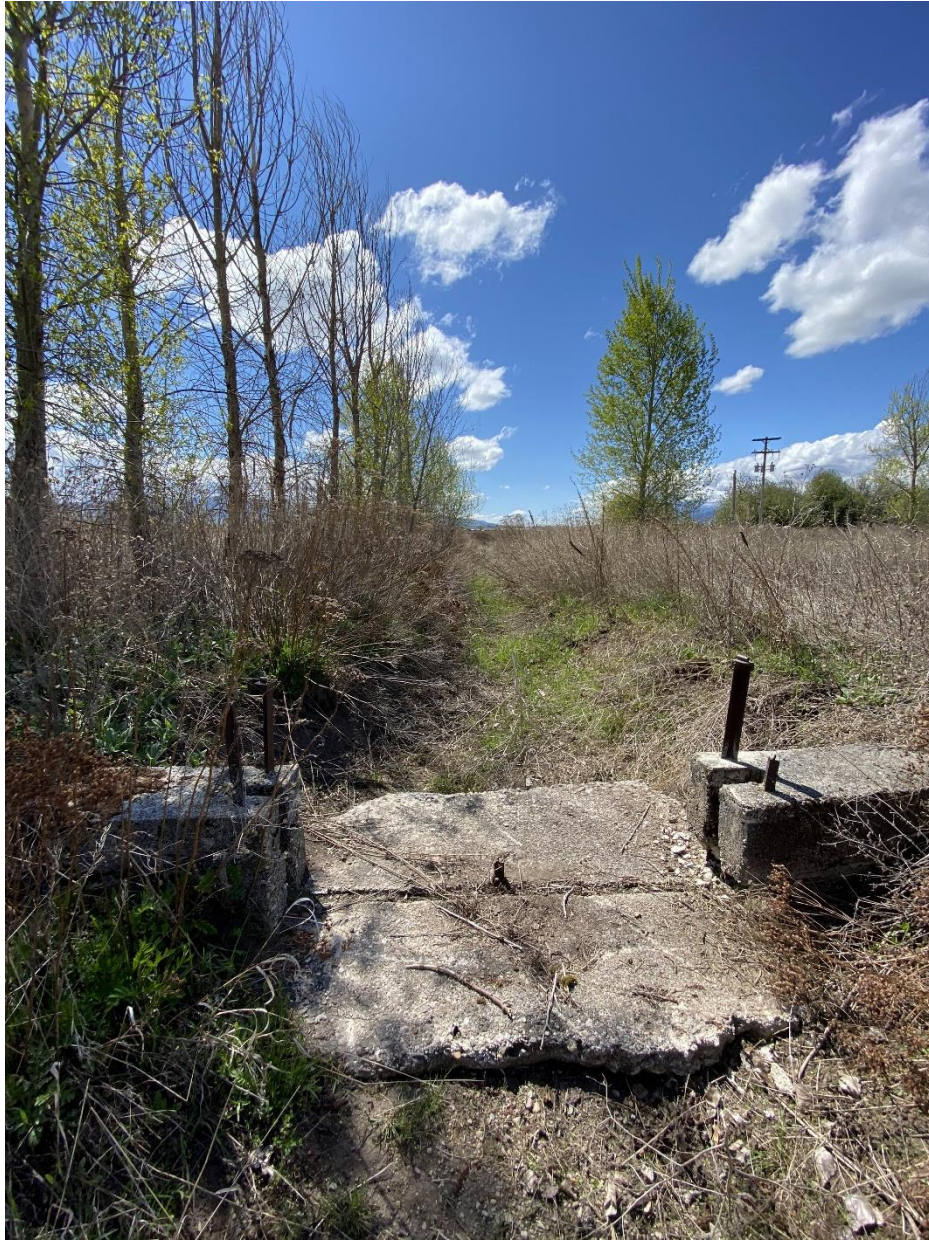
Abandoned headgate structure on the Flynn-Dougherty Ditch (24MO0901) at the Dougherty Ranch, view to the south.

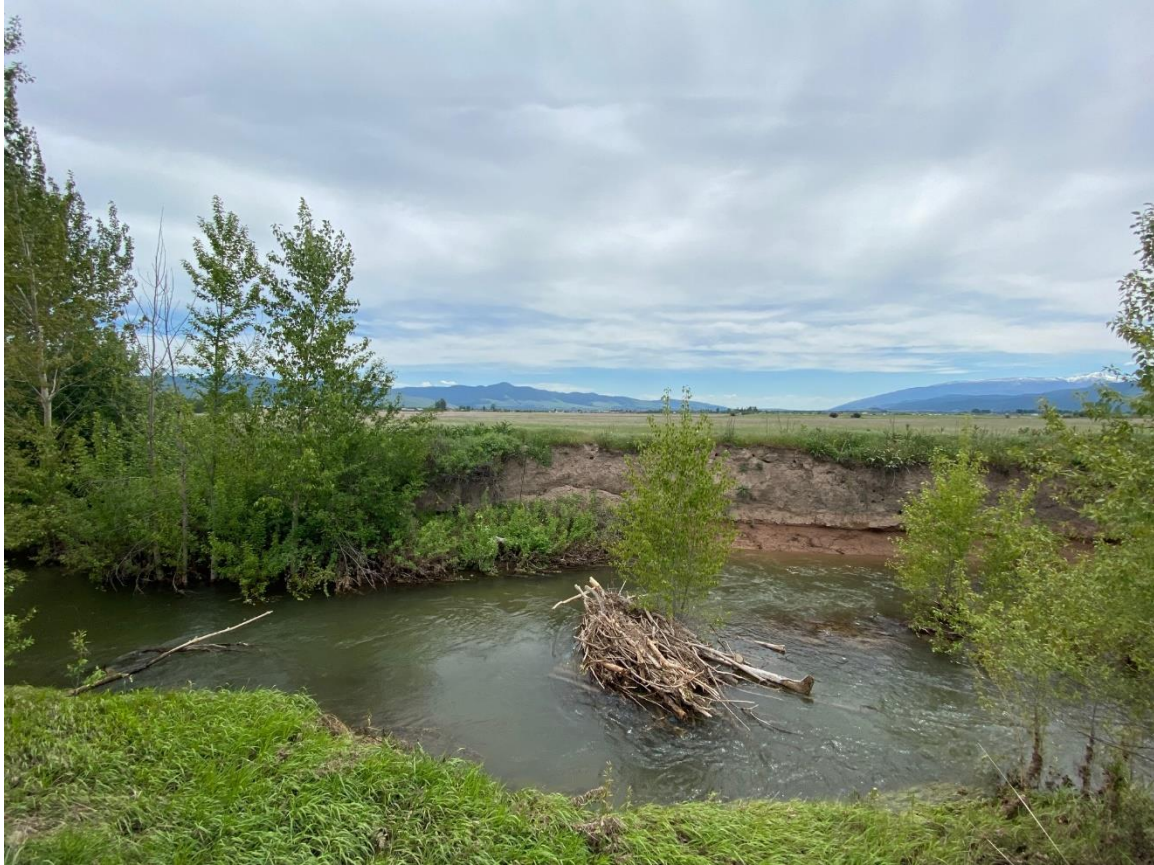
The Field Dougherty Ditch (24MO0902)/Grant Creek near the proposed intersection of George Elmer Dr. (north segment) and West Broadway. View to the south.

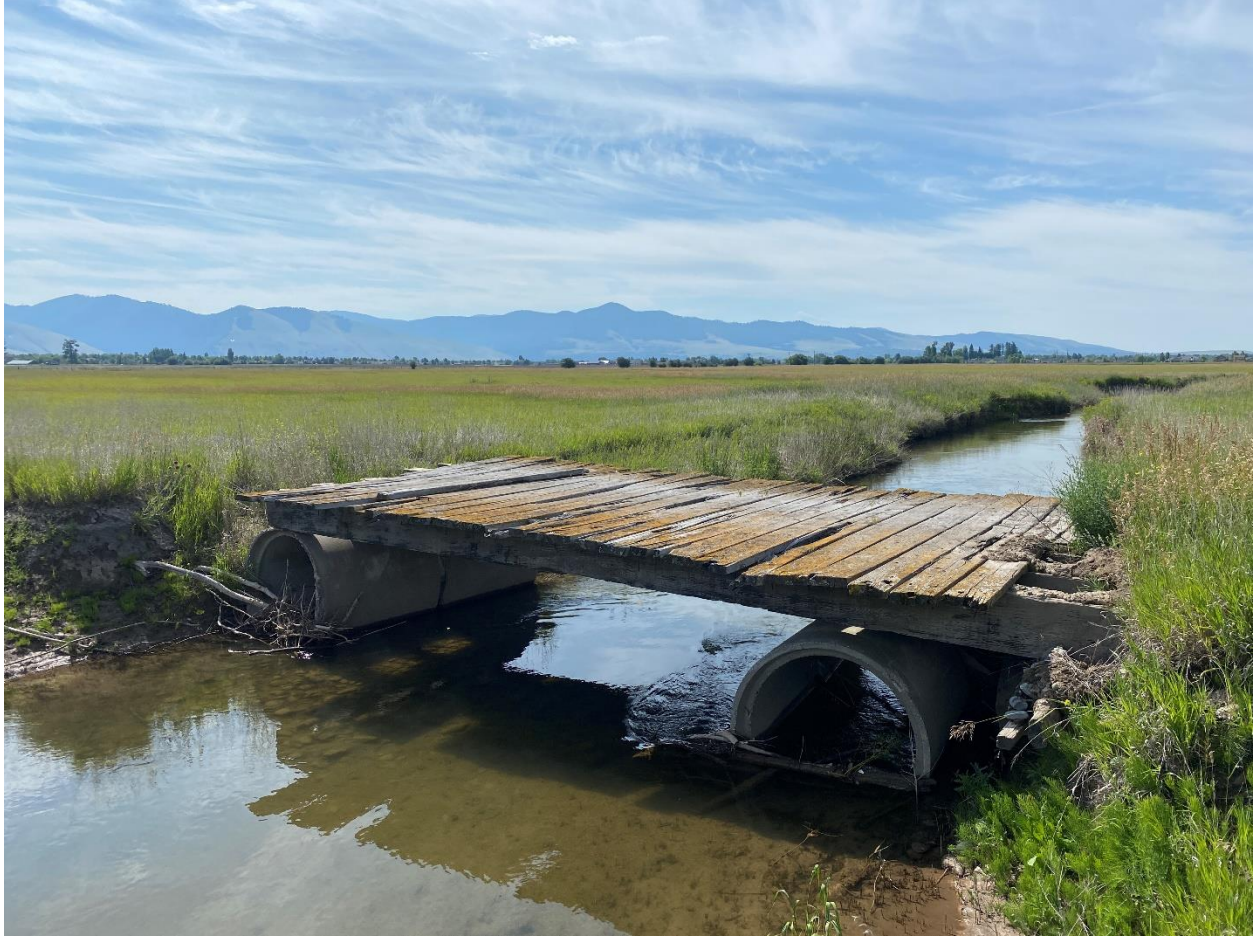
The Field Dougherty Ditch (24MO0902)/Grant Creek. Plank bridge originally recorded by Herbel and Beery (2006:20). View to the south.

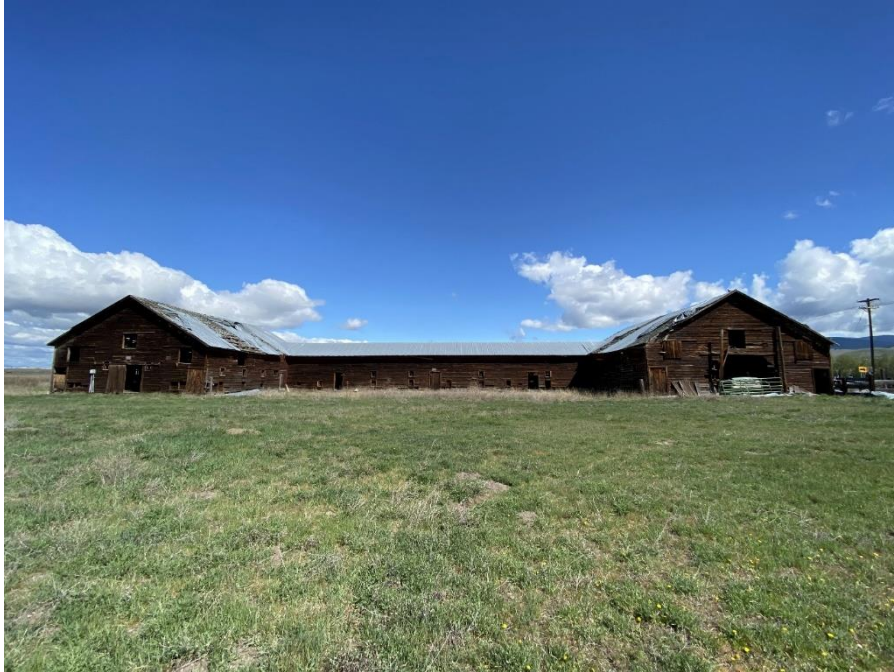
**Barn:** The barn is a circa 1920<sup>6</sup> front facing compound U-plan style stock barn. It is one and a half stories, with a low-pitch single-end-view gable per roof line in the plan. The barn is oriented with its front to the south with each wing having front gables and the median span having a cross gable. Roofing materials consist of corrugated tin sheets covering decomposing asphalt shingles. The barn sits on an uncut stone and mortar foundation, likely from stones that would have been available on site or locally. Each wing measures approximately 60 by 40 ft with the central span running approximately 125 by 20 ft. The Montana Cadastral Property Record Card lists each wing at 2436 square feet (sq ft) and the center span a 3080 sq ft for a total of 7952 sq ft of a standard barn(s) that constitutes building improvements 4-6.

Photograph of the barn, view to the north.

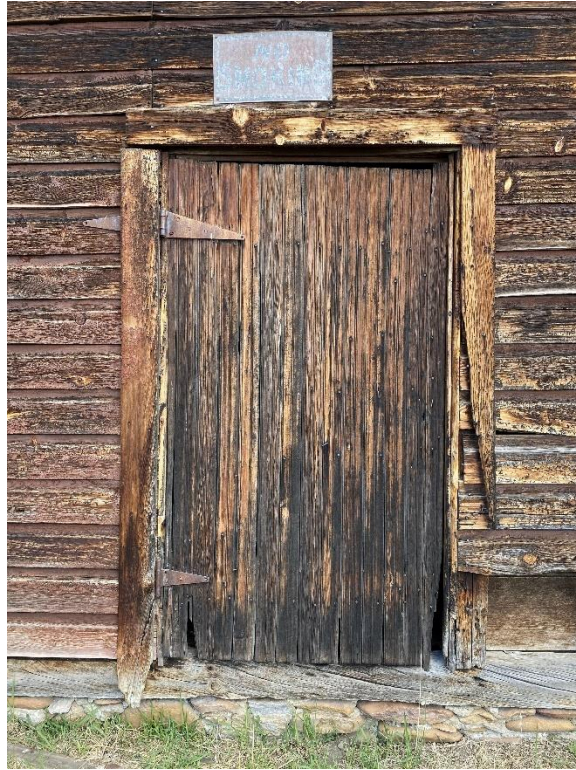
Photograph of representative door on the north elevation, showing door type, casement, and the uncut stone foundation.

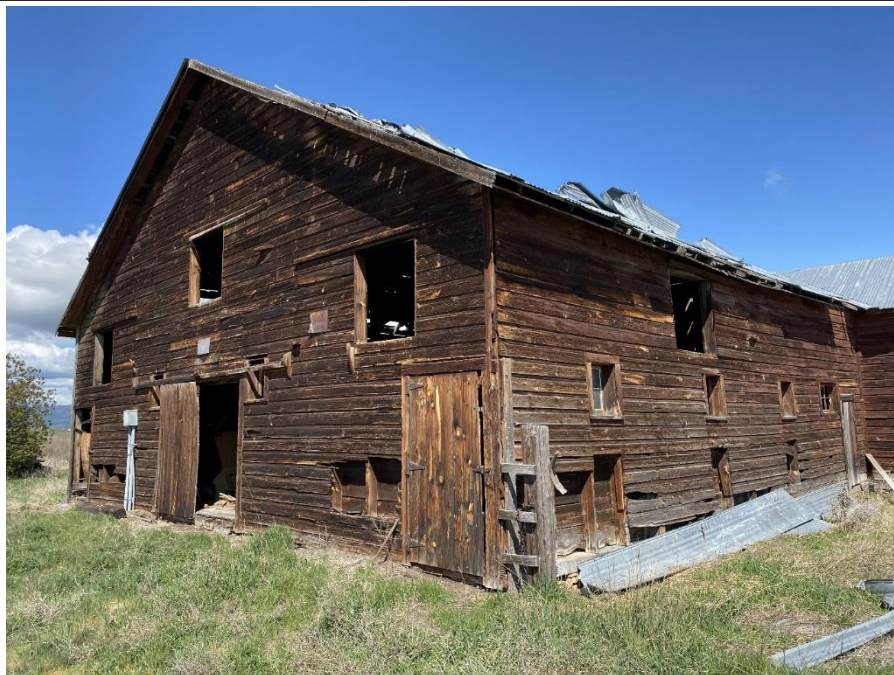
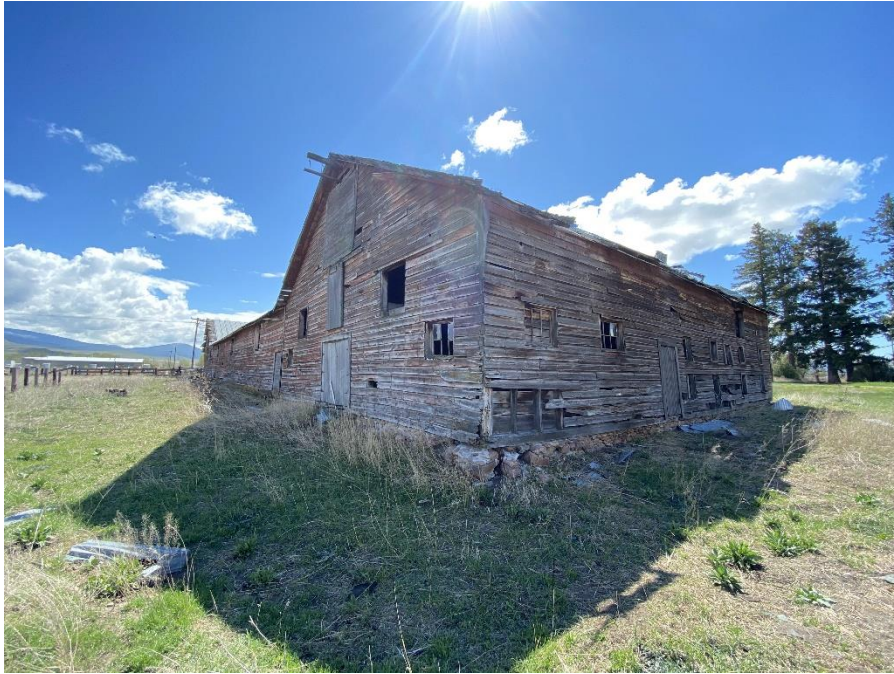
Photograph of the southeast corner of the west wing, view to the northwest.

The south elevation of the wings both possess a series of three 6 ft square sliding doors as egress to the upper loft and two primary entry doors that are identical to those found on the south elevation of the center span. The east wing has a larger central opening for vehicle access while the west wing has a smaller 8 ft square slider door.

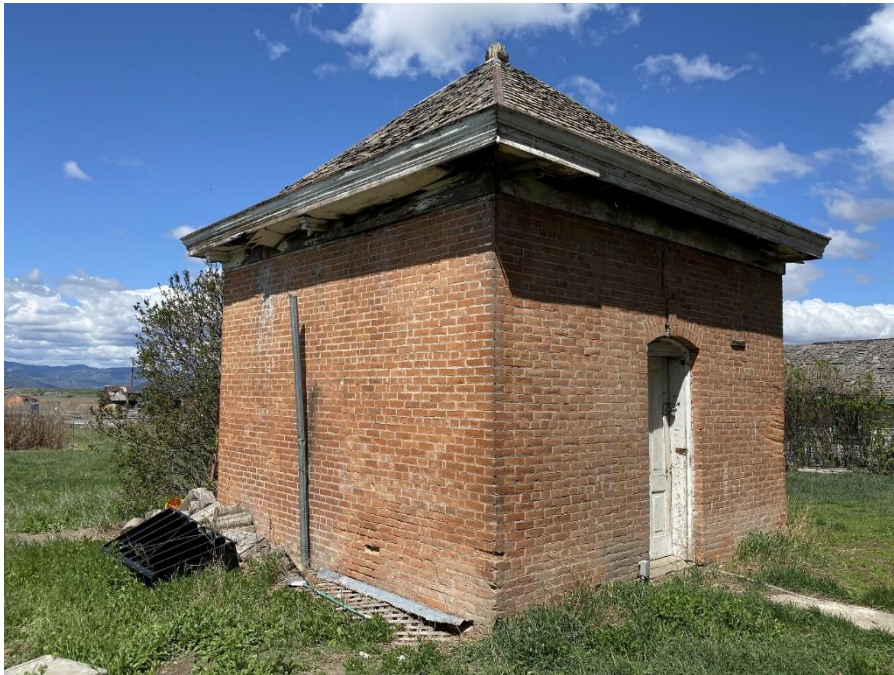
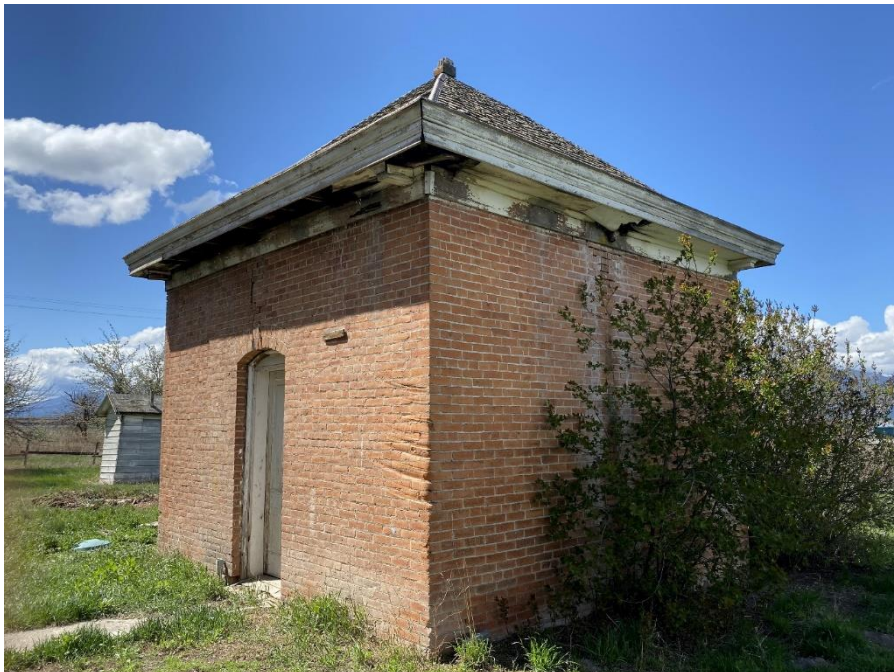
**Icehouse:** The icehouse a 324 square ft (18 by 18 ft), one-unit simple plan building with a normal pitch pyramidal roof line and plain wood shingles. There is a single two-panel entry door on the east elevation closest to the house. The door has a deep casement and a brick piedmont identical to the house. It also has an identical wide-eave with brackets as the house. The foundation is irregular-course cut stone and the brick pattern is English with seven rows of stretchers per header row. The west elevation is obscured by a lilac though has a single wood frame, fixed window

with brick pediment. This buildings construction was likely contemporaneous with the house given array of matching features.

Southeast corner of the icehouse showing the south and east elevations.

Northeast corner of the icehouse showing the north and east elevations.

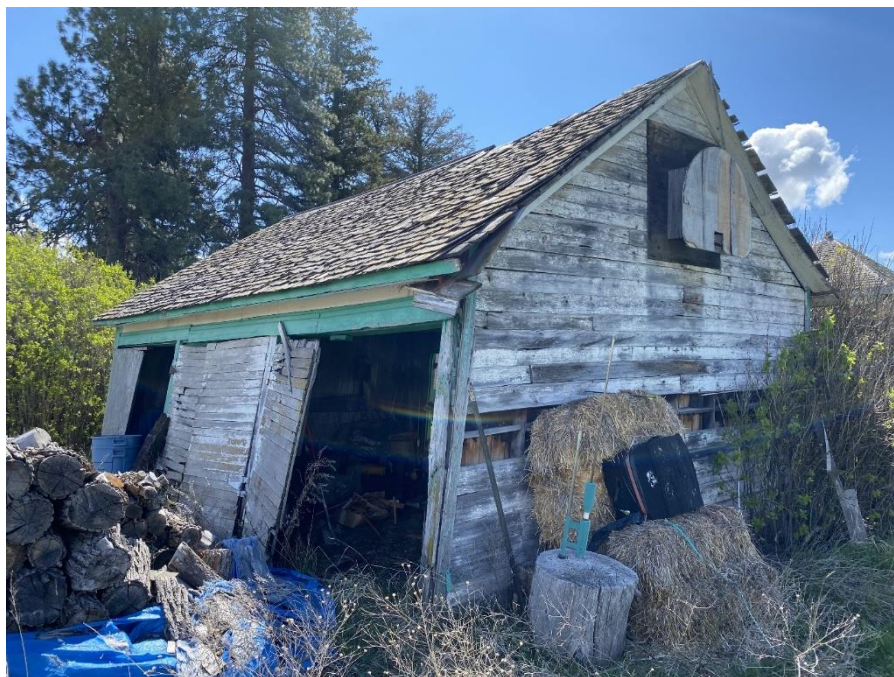
**Garage:** The garage is ca. 1920, 450 square ft, detached three-bay garage that opens to the north with standard hinged plank doors. It is side-gabled, medium pitch, with a basketball hoop on the west elevation. Shingles are plain wood

shake shingles and there is a standard door opening on the south elevation with a poured cement path that leads to the house. There is a single three-over-three six-light window on the south elevation just west of the door.

Northwest corner of the garage showing the north and west elevations.

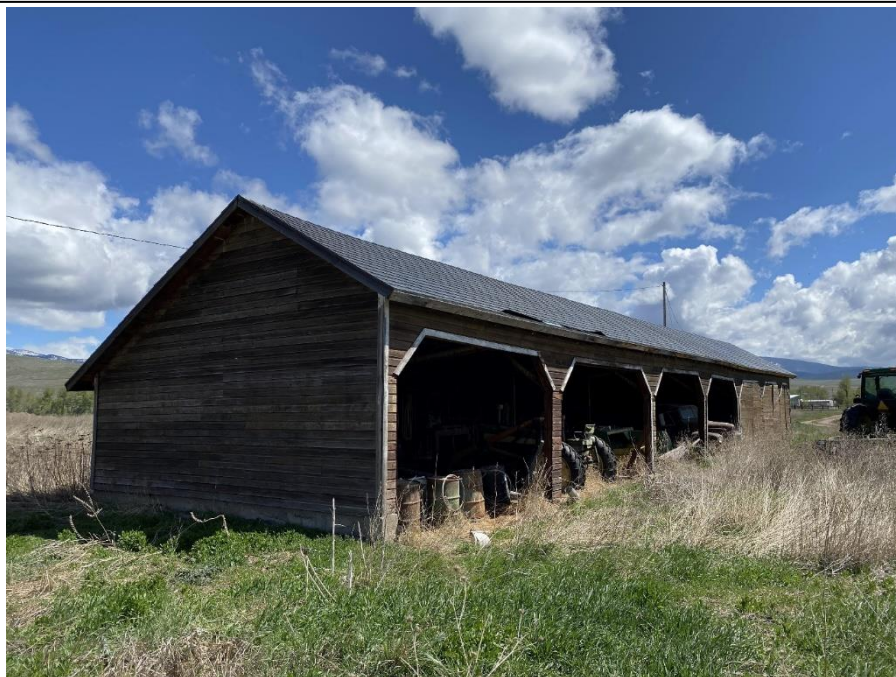
**Equipment Shed:** This six-bay equipment shed is ca. 1930 and approximately 2500 square ft (100 by 25 ft). The westernmost four bays are open while the easternmost three have hinged plank doors. The east elevation has single three-panel man door and a three-over-three six-light windows. The saltbox style building is side-gabled, normal pitch with eaves, with composite shingles. The west elevation has no features, while the north elevation has one small wood casement fixed three-light window with a wood sill. The interior is home to tractor parts, tires, oil drums, implements for hay production, and a 1949 International Harvester flatbed truck that does not appear to be in working order.

Southwest corner of the equipment shed showing the south and west elevations.

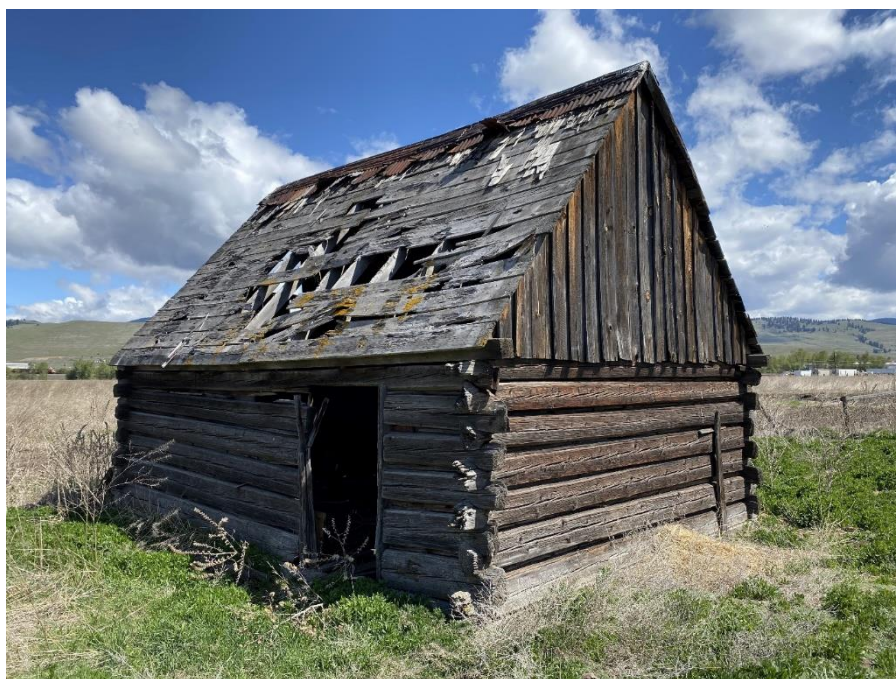
**Cabin:** The cabin is a steep-pitched side-gable cabin with seven courses of diamond-notched logs. It has 391 square ft (17 by 21 ft) and a door in the west elevation. No windows are present. Corrugated tin roofing covers and older layer of simple rectangular shingles. It is not clear what the function of this cabin is. It is possible that this was a dwelling occupied by the England family prior to the construction of the main house.

Southwest corner of the cabin showing the south and west elevations.

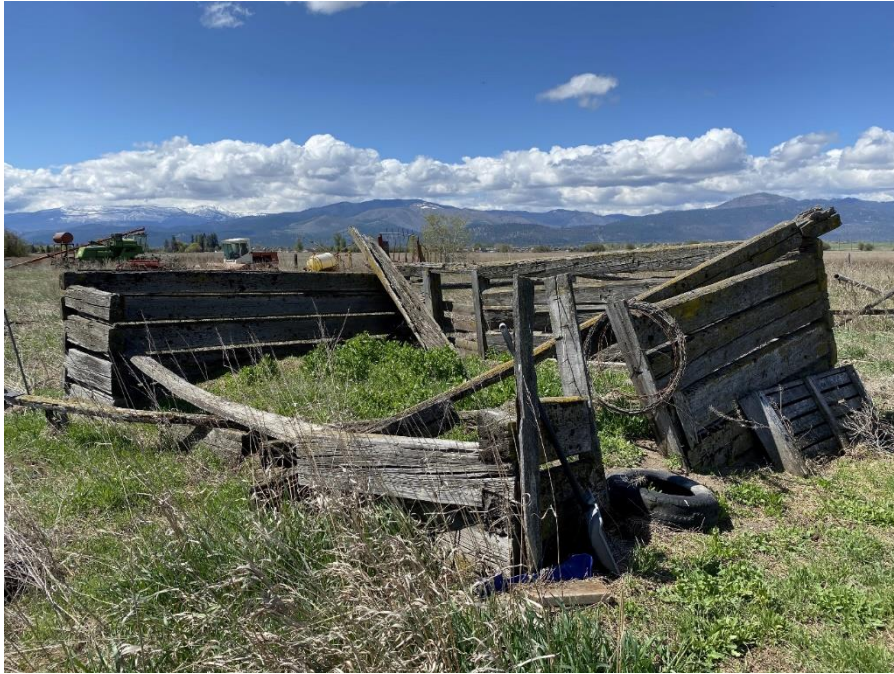
**Feature 1:** Feature 1 is the remains of 19 by 13 ft, six-course high log building. The logs are milled and dovetail notched. It is likely that this structure would have been contemporaneous to the cabin located nearby and was likely a small barn.

Overview of Feature 1, view to the south

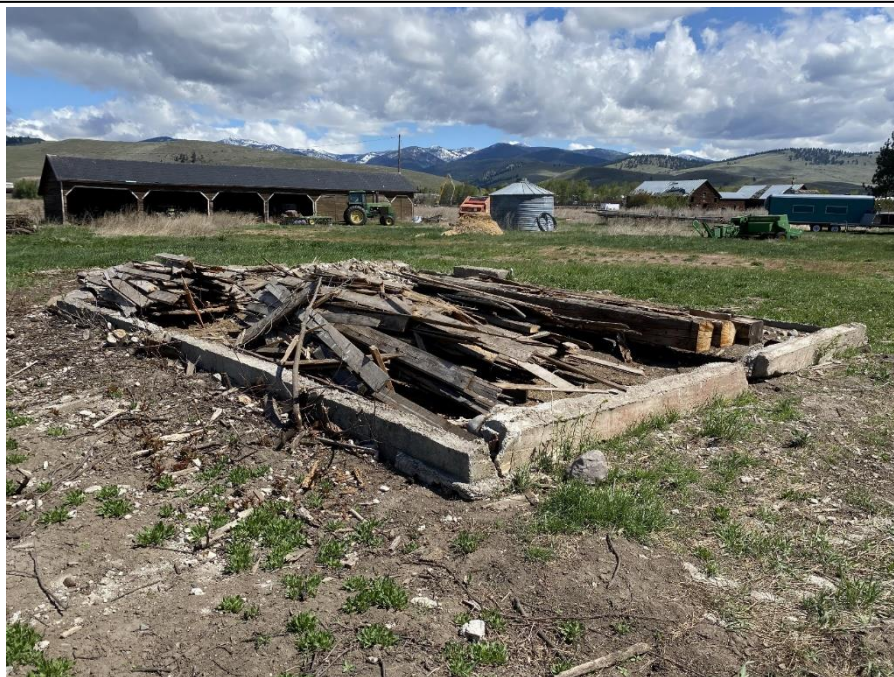
**Feature 2:** Feature 2 is a 20 by 30 ft cement foundation with miscellaneous building debris within. Earlier air photos (ca. 2016) of the site show a building present here that has since been torn down.

Overview of Feature 2, view to the north

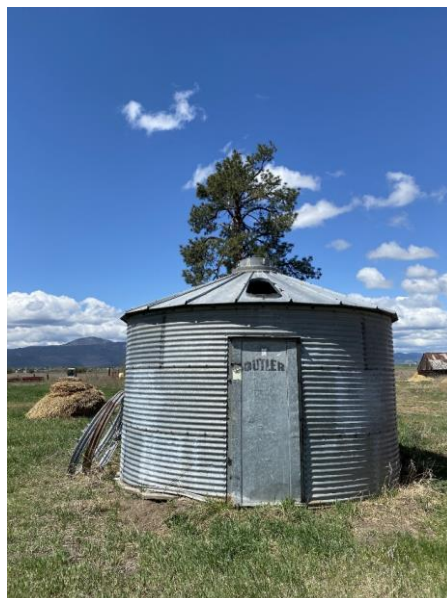
**Grain Bin:** The grain bin is galvanized steel, 14 ft in diameter and 8ft in height. The door is stamped with “BUTLER MFG COMPANY”. The capacity of this bin would have been approximately 985 bushels of grain<sup>7</sup>.

Grain bin, view to the west

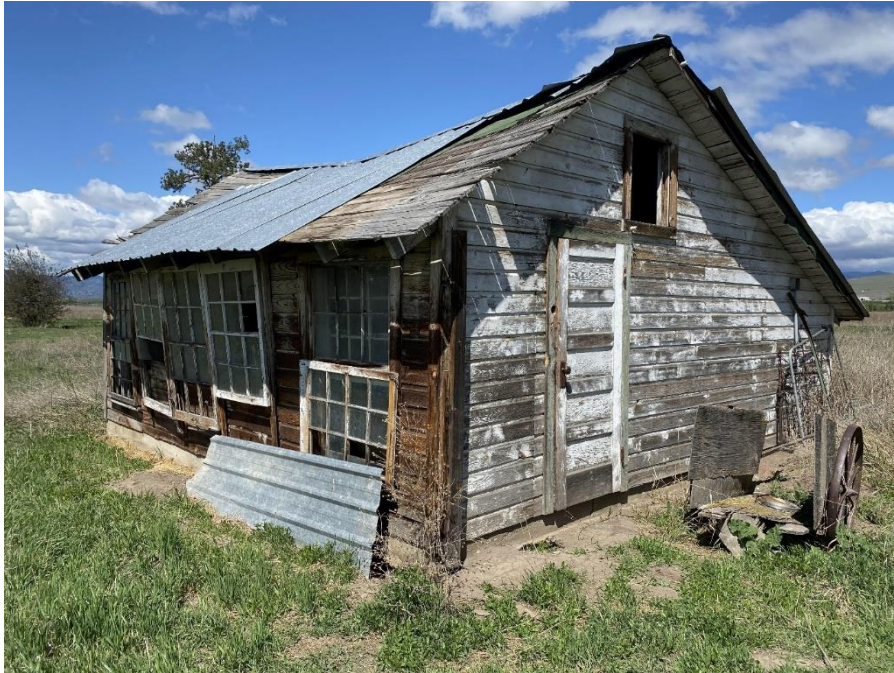
narrow 6 panel door on the east elevation. The interior has an array of gardening equipment and nesting boxes. Land to the north of this building is where a large garden had been present in the past.

Southeast corner of the coop showing the south and east elevations.
