# Aquatic Resources Report

## ***Mullan BUILD Project***

*Missoula County, Montana*

**October 8, 2020**

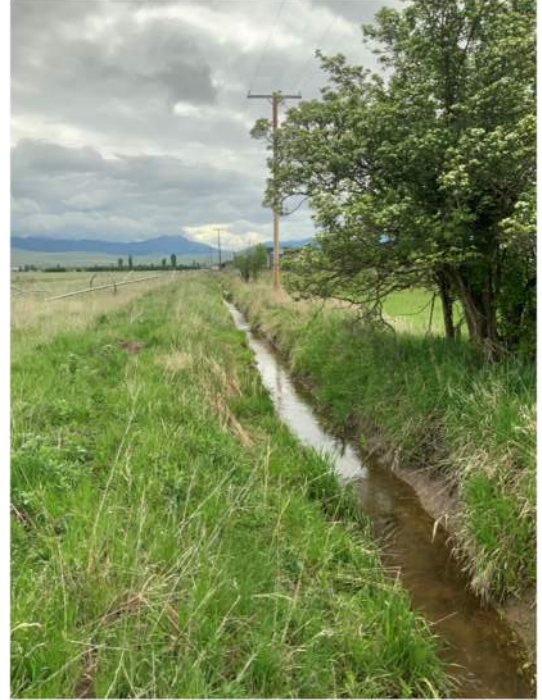
Photo 14. Lateral 2 of Flynn-Lowney Ditch, looking east.

This ditch is a lateral ditch ranging approximately 4 to 10 feet in width that begins at a diversion of the Flynn-Lowney Ditch near Tipperary Way, just east of George Elmer Drive. The lateral ditch flows in a northerly direction for approximately 0.7 mile, turns west for .25 mile, then flows north for 0.25 mile and flows into Grant Creek. This lateral is not crossed by any transportation element of the project; however, there is potential that the ditch conveyance flowing west from the 44 Ranch Estates development could be used to convey stormwater from George Elmer Drive. This ditch was actively conveying water westward and flowing into Grant Creek during the field investigation.
